May 25, 2022 Revised March 17, 2023

To:	Ben McPherson, Angie Martin
From:	John Black, Daniel Flanigan
CC:	Matt Reardon, Brandon Mikolin
Re:	Pipe Rack Pipe Leak Work Plan Operable Unit 3 – Site 108 3800 River Road Town of Tonawanda, New York

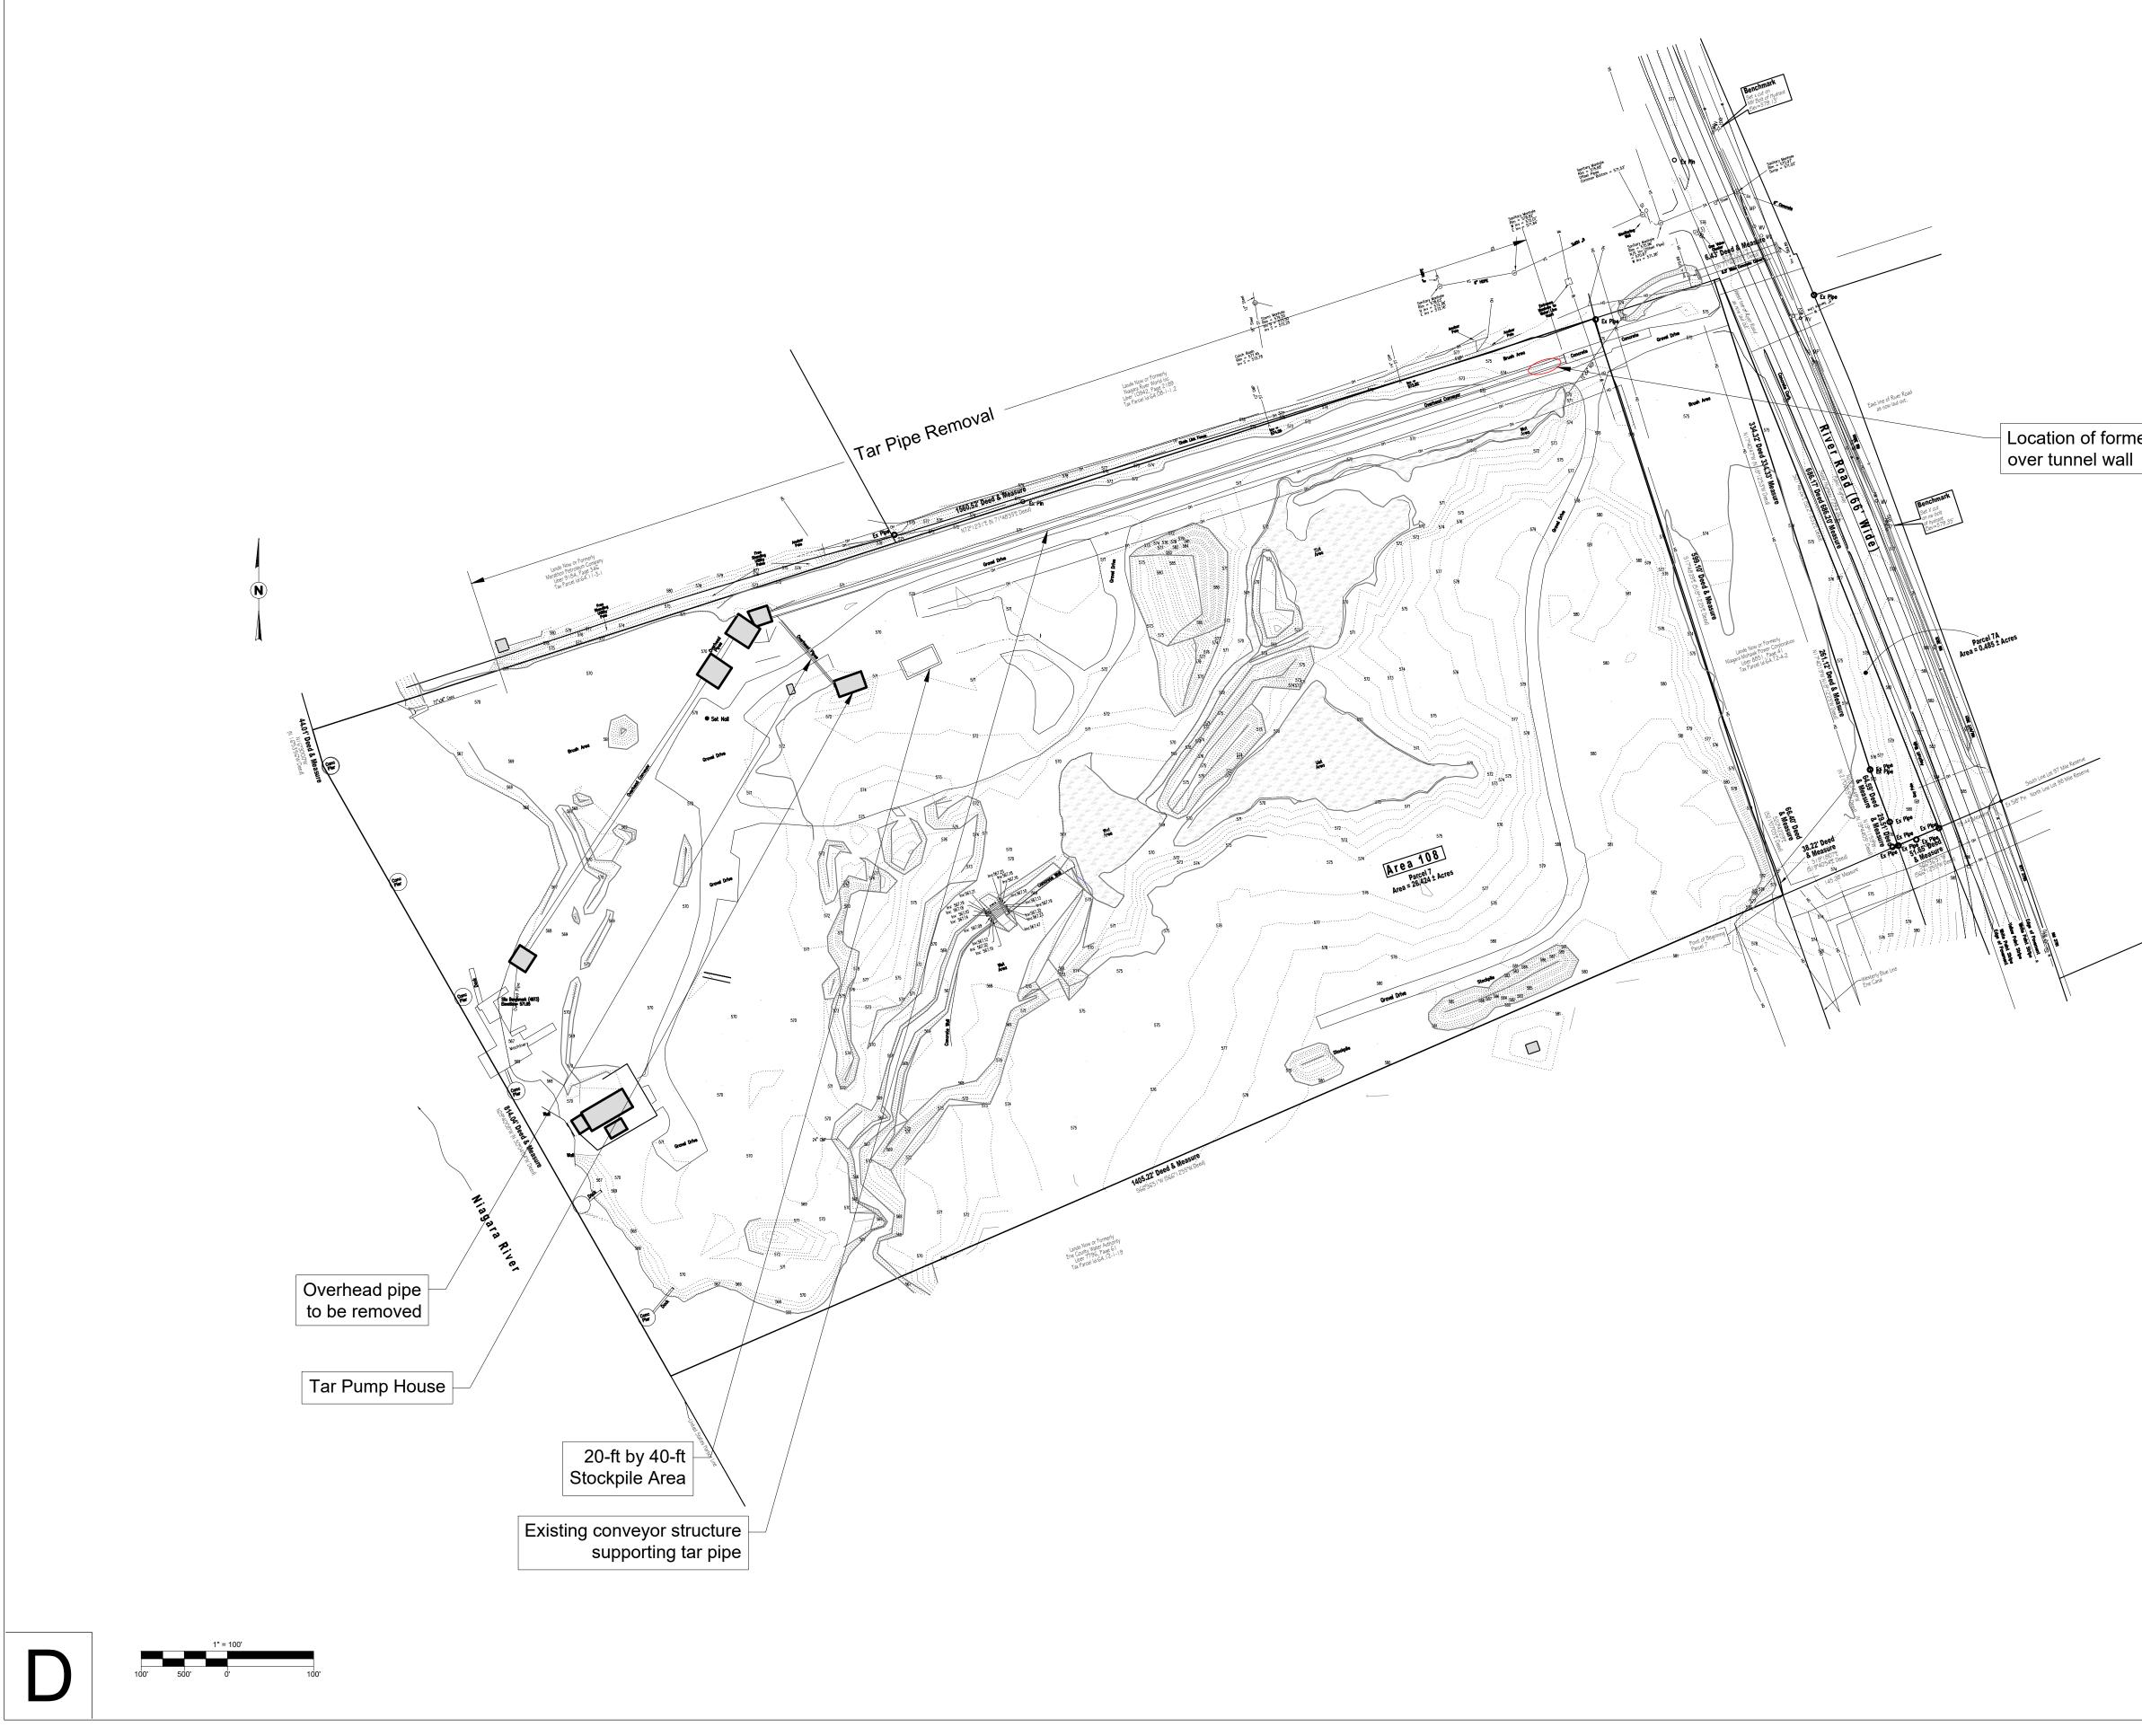
FIGURE 1 DRAWING NUMBER

In the late afternoon of May 12, 2022, a tar leak was observed during a routine inspection on the south side of the main pipe rack / conveyor system on 3800 River Road (a/k/a Site 108, NYSDEC #915055). The conveyor and pipe rack were former Tonawanda Coke Corporation (TCC) structures used to carry tar, coal, and coke to and from barges and ships docked in the Niagara River. The structure also supports the primary 2,300-volt electrical supply for the BCP Site. The pipes on the structure (Figure 1) and their assumed content include:

Location of former tar seep

The tar pipes (Figure 1) shall be removed and disposed offsite to eliminate the risk of a release and to reduce the labor required to inspect, reseal, and manage leak materials. The removal would include:
