Pre-Demolition Asbestos-Containing Material Survey Report

**Tonawanda Coke Site 108
3800 River Road
Tonawanda, New York**

CHA Project Number: 35547

January 20, 2020

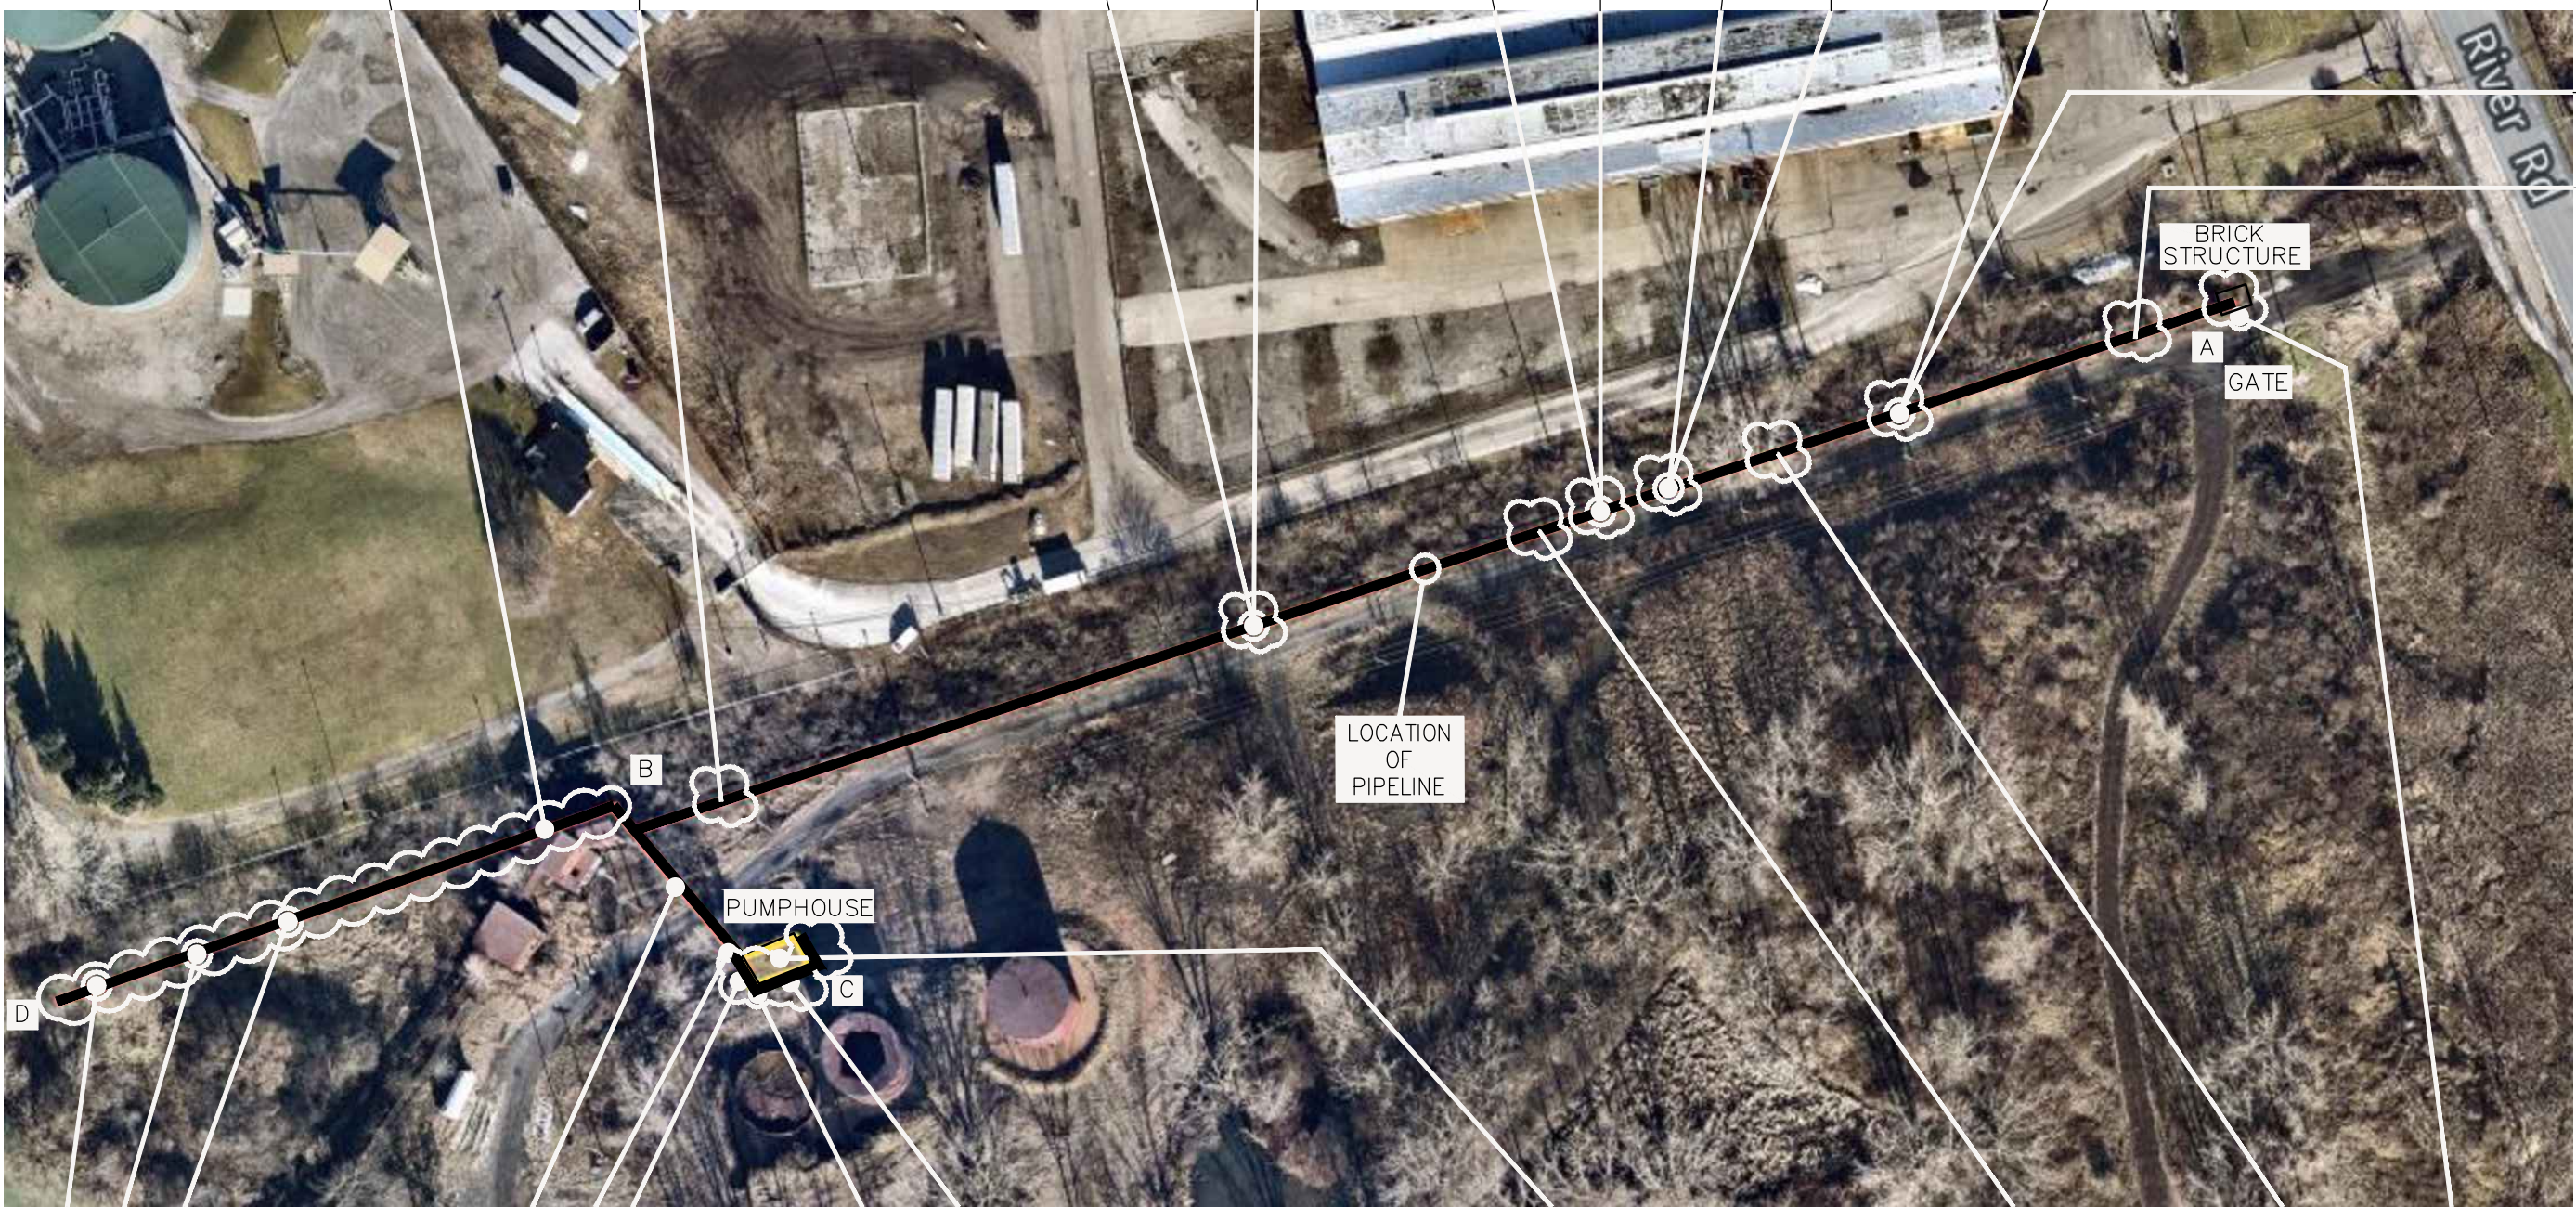
FIGURE 1

In order to distinguish separate segments within the Site, CHA designated the following locations on Figure 1:

- Brick Structure – Point A
- Piping Branch near Pump House – Point B
- Pump House – Point C
- Western End of Pipeline – Point D

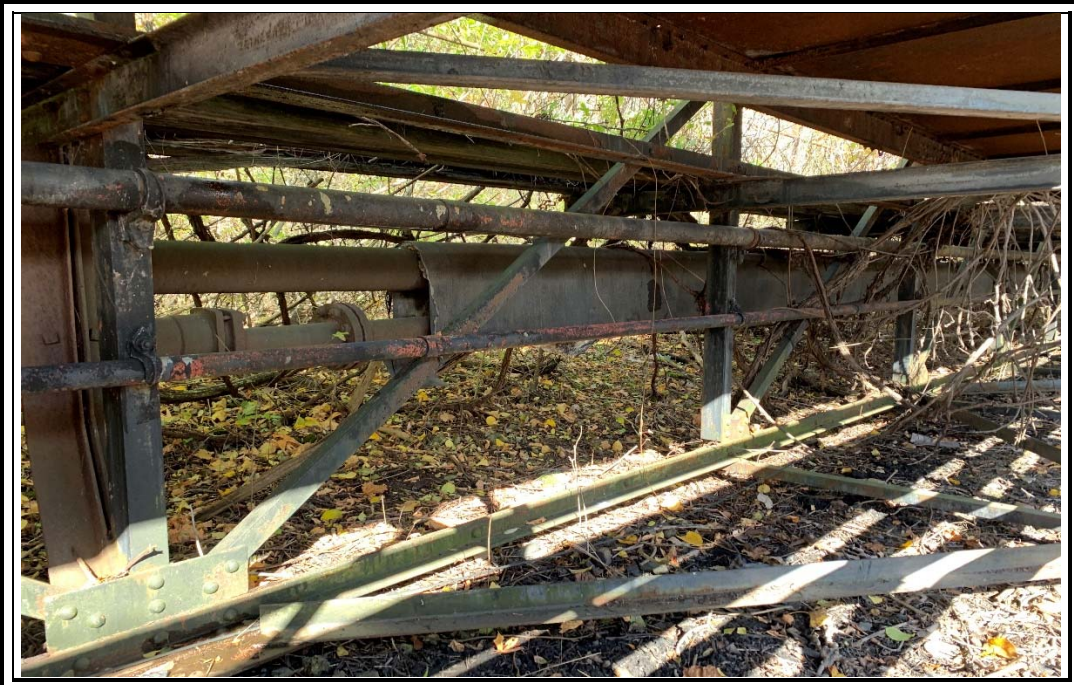
Eight areas of suspect asbestos-containing white pipe insulation and/or black felt pipe insulation wrap debris was noted below the pipeline between Points A and B. An overhead wooden walkway covered the two pipes between A and B and suspect asbestos-containing white pipe insulation and black felt wrap were in relatively good condition compared to other areas. Each of the eight debris areas were approximately 100 square feet in area on the ground.

Photo 1 – Typical pipe insulation with overhead protection between Points A and B

- CHA recommends that the asbestos-containing pipe fitting insulation, white plaster pipe insulation, and black felt pipe insulation wrap be removed throughout the entire pipeline, including inside and outside the Pump House. Pump House window glazing and caulk, door caulk, wire insulation, gaskets, roof vent sealant and black pitch will need to be addressed as part of any building renovation or demolition project.

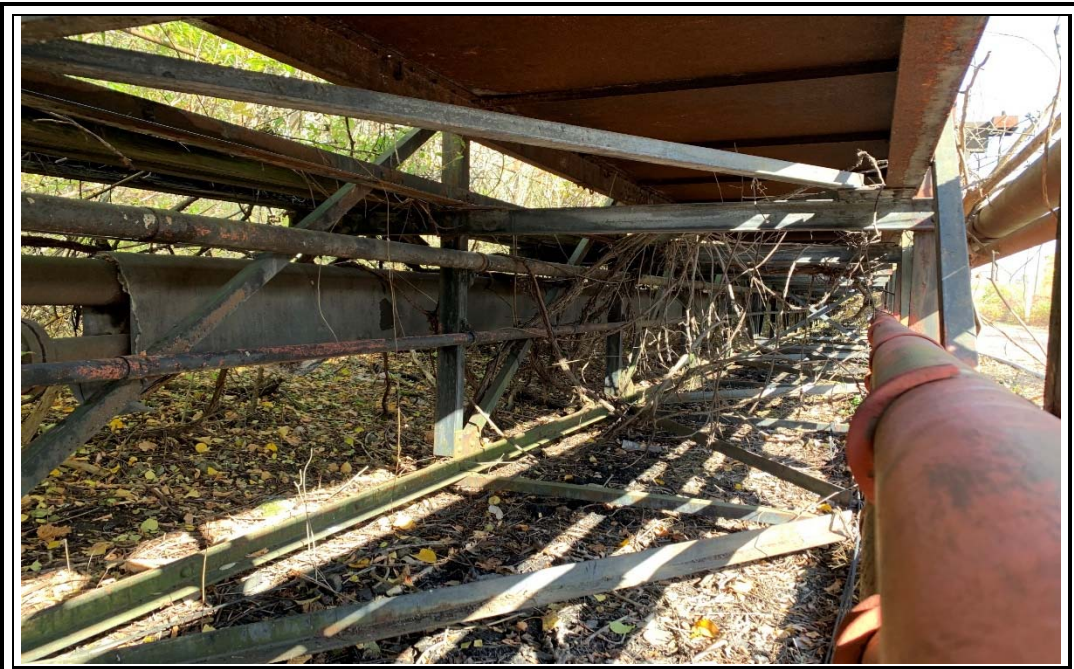
Photo 2 – Typical pipe insulation with overhead protection between Points A and B

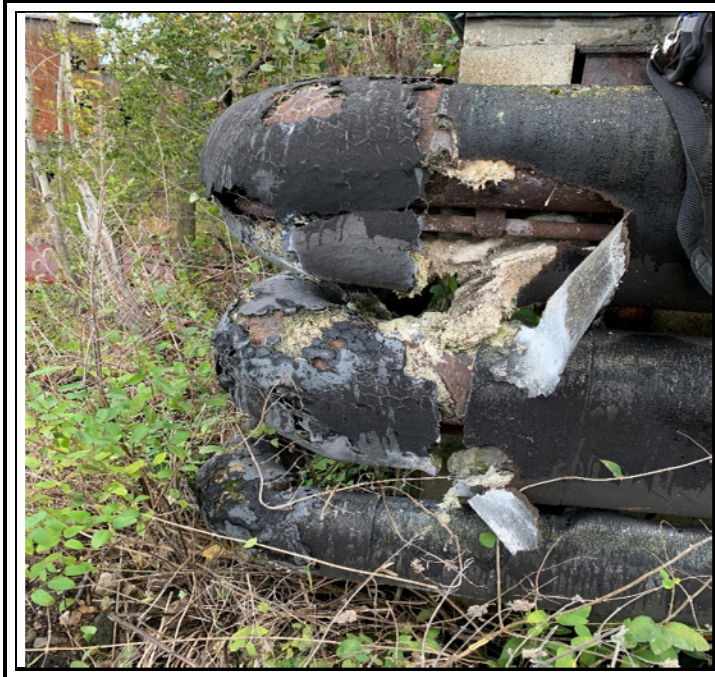
Photo 3 – Typical pipe insulation between Points B and C

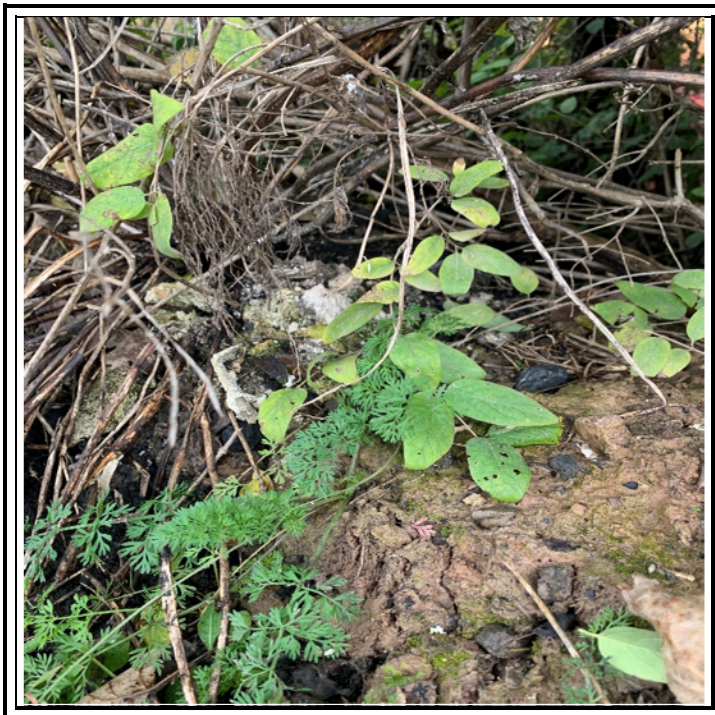
In addition, suspect asbestos-containing white pipe insulation debris was observed on the ground immediately adjacent to the South, East, and West sides of the Pump House. The area of debris is approximately 36 feet long by 10 feet wide. CHA, observed no asbestos suspect asbestos-containing white pipe insulation debris associated with the pipe bridge between Points B and C.

Photo 4 – Typical pipe insulation debris adjacent to Pump House

- Based on the discovery of the confirmed asbestos-containing debris on the ground surface underneath and adjacent to the pipeline, and immediately adjacent to the Pump House, CHA recommends that the asbestos-containing debris be removed. Based on the heavy vegetation located between Points B and D, additional quantities of asbestos-containing debris are possible. In addition, soil removal will most likely be necessary to completely remove asbestos-containing debris from the ground surface. Given the debris is greater than 10 square feet, a site specific variance will be required from NYS DOL.

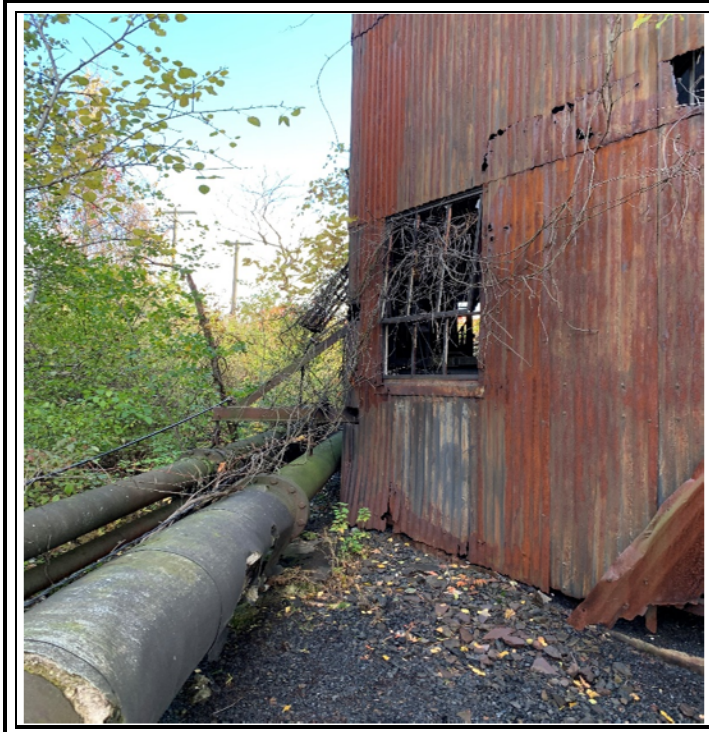
Photo 5 – Typical pipe insulation between Points B and D

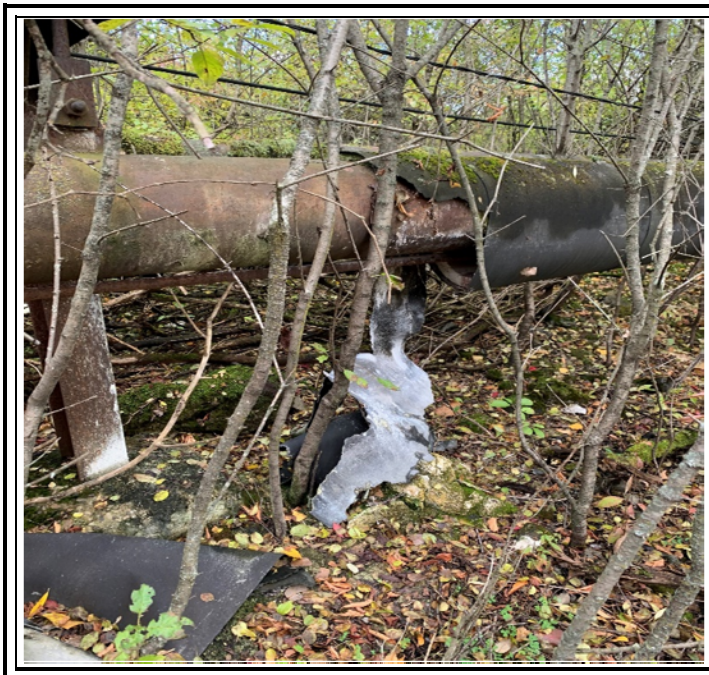
Similar to the pipe run located between Points A and B, CHA observed several areas of suspect asbestos-containing white pipe insulation and/or black felt pipe insulation wrap debris located underneath the two pipe runs between Points B and D. These two pipes were not protected by an overhead walkway and the suspect asbestos-containing white pipe insulation and/or black felt pipe insulation wrap was in poor condition. A majority of white pipe insulation was missing; however, the pipe insulation was not observed on the ground surface. CHA believes the white pipe insulation may have been covered by the vegetation and/or soil. Black felt pipe insulation wrap debris was, however, noted on the ground surface. The area of debris is approximately 360 feet long by 10 feet wide. Also, CHA observed heavy vegetation along the pipeline between the B and D which could prevent observation of the debris.

Photo 6 – Typical pipe insulation debris between Points B and D

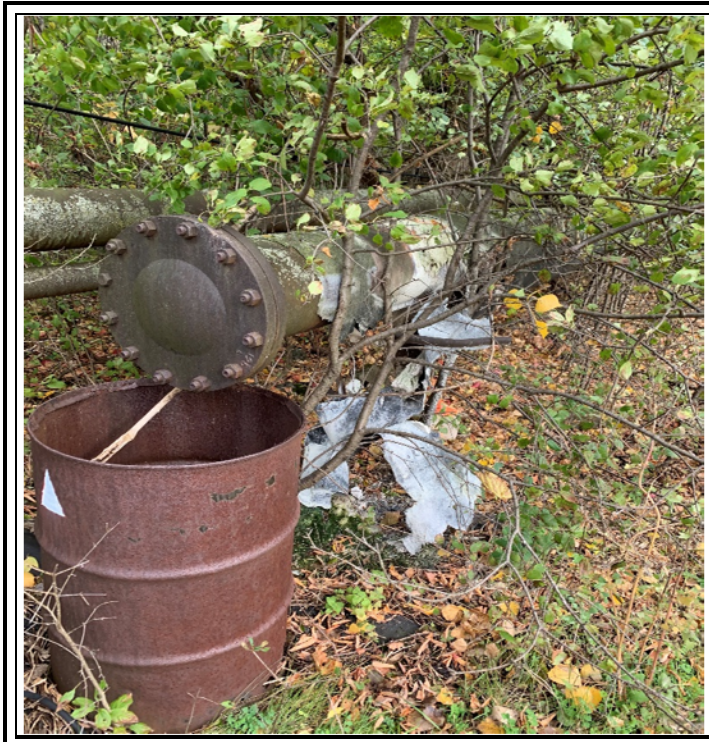
Photo 7 - Typical pipe insulation debris between Points B and D

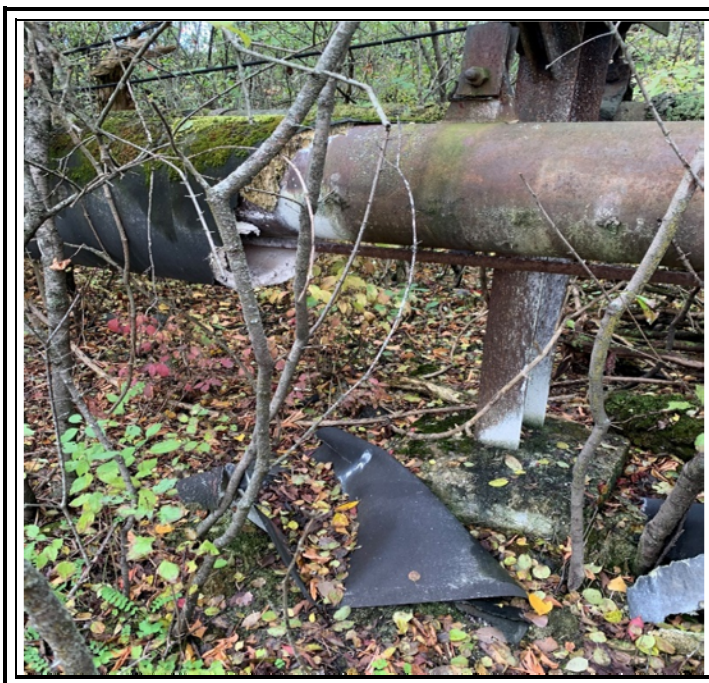
Photo 8 - Typical pipe insulation debris between Points B and D

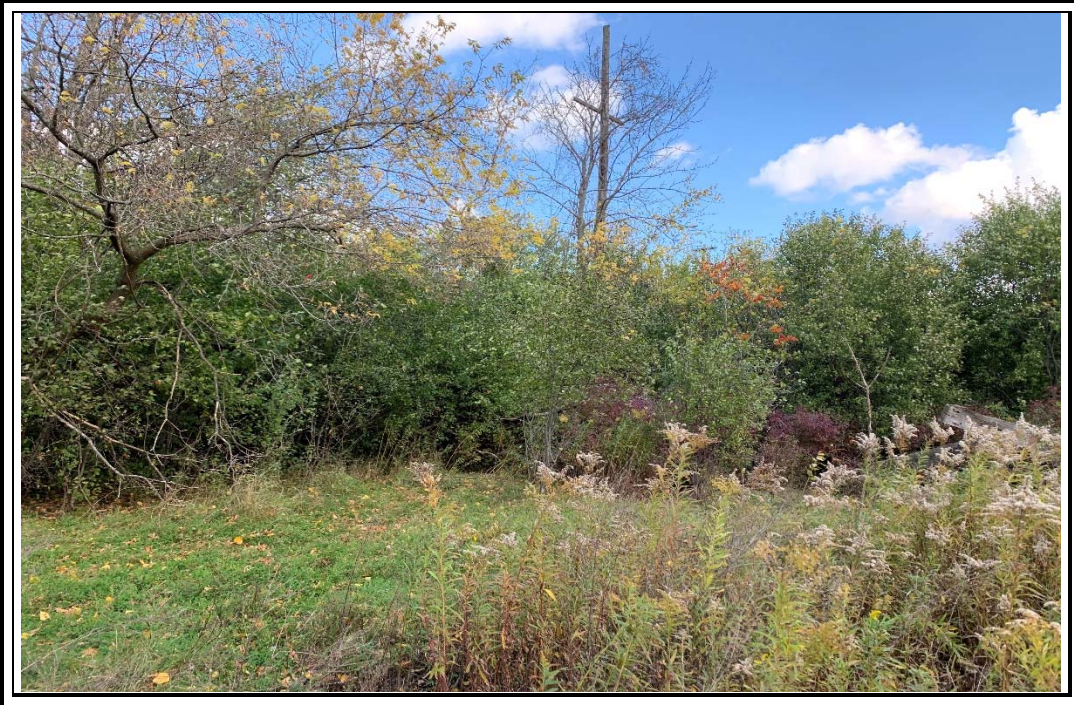
CHA noted heavy vegetation immediately below and adjacent to the pipeline between Point B on the Pipeline and Point D, the Niagara River. Parsons cleared two to three locations of vegetation for this asbestos inspection to access the piping rack for sample collection. Also, due to the approximately 5' of standing water in a Brick Structure where the pipeline originated, this area was inaccessible.

Photo 9 – Heavy vegetation between Points B and D

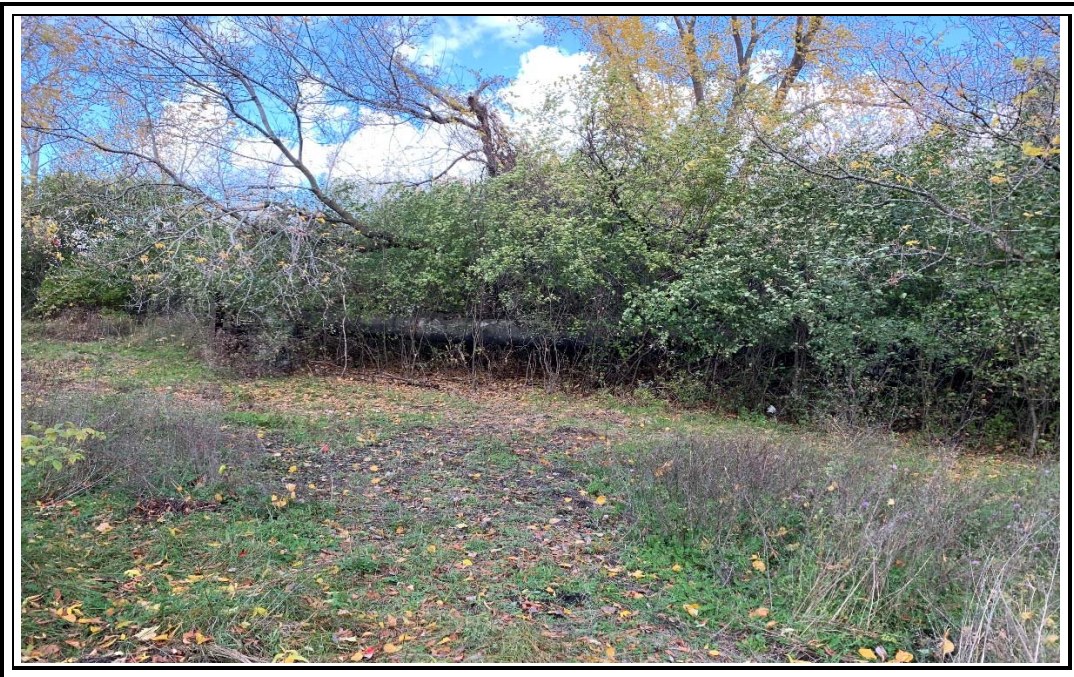
Photo 10 – Heavy vegetation between Points B and D

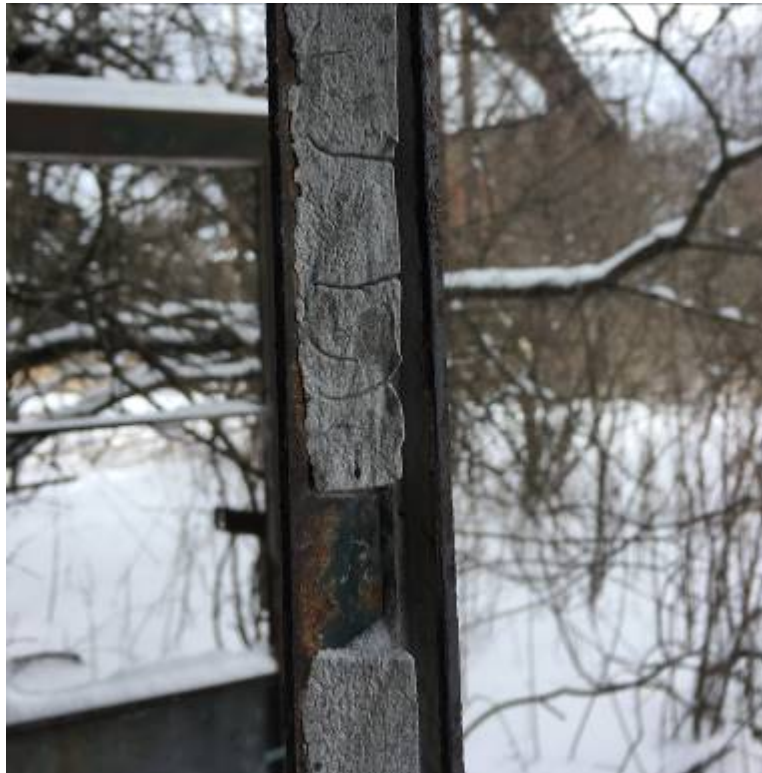
Window glazing

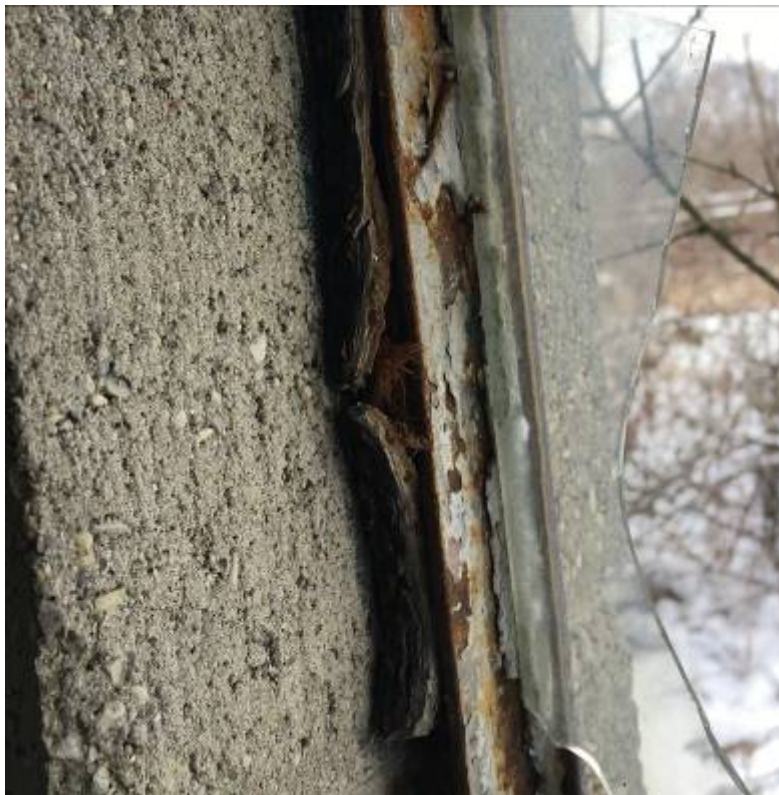
Window caulk

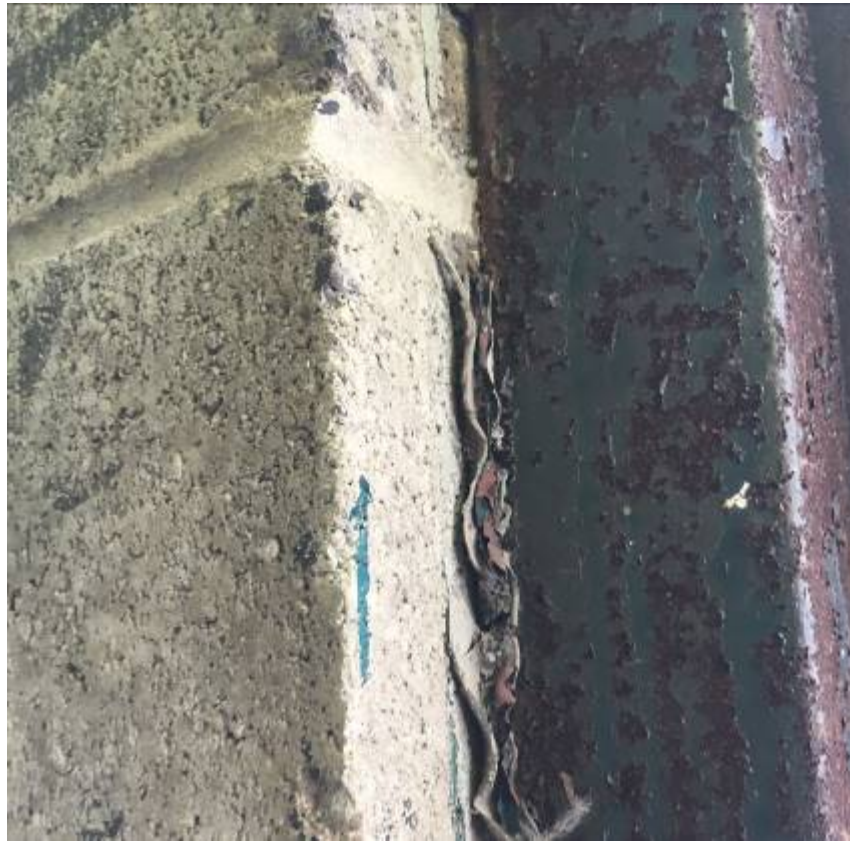
Door caulk

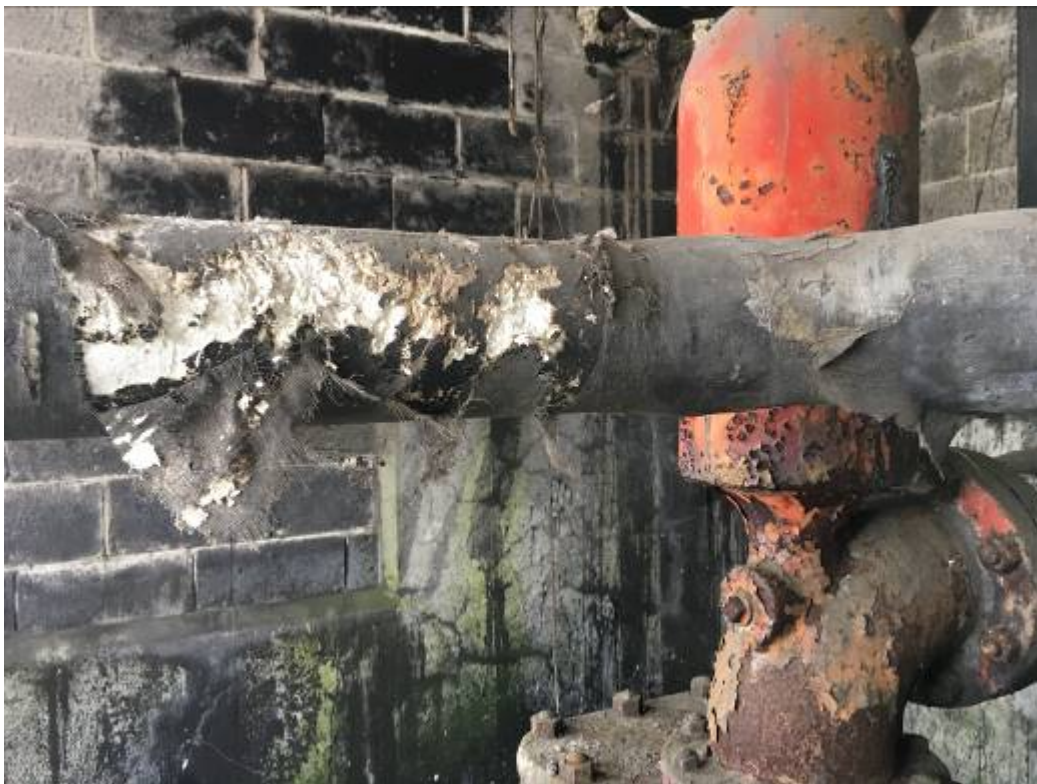
Black cloth pipe wrap over white pipe and fitting insulation

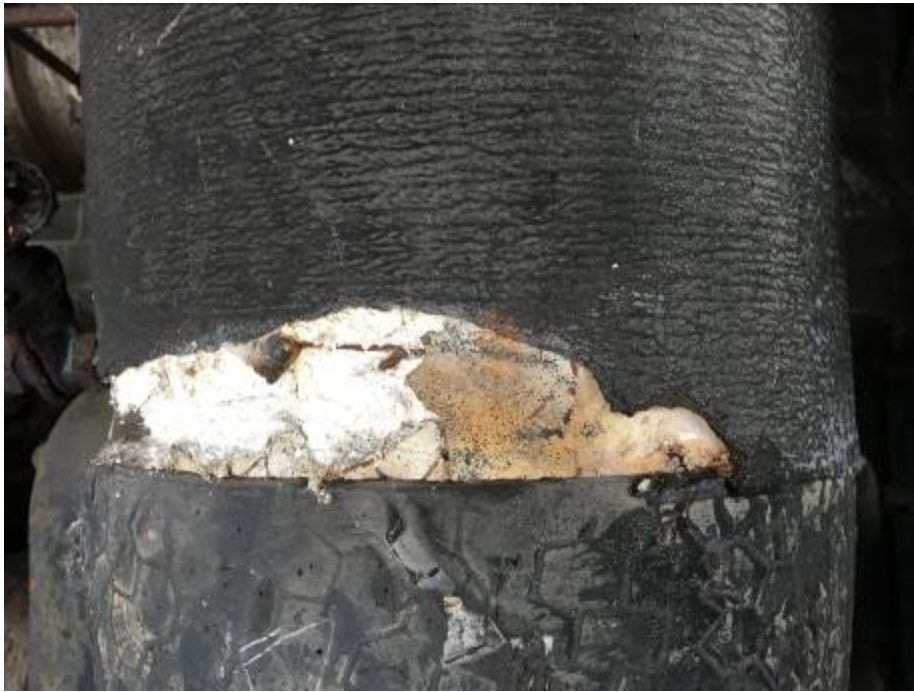
Black pipe wrap with wire (lower pipe) and tar-paper-like wrap on upper pipe

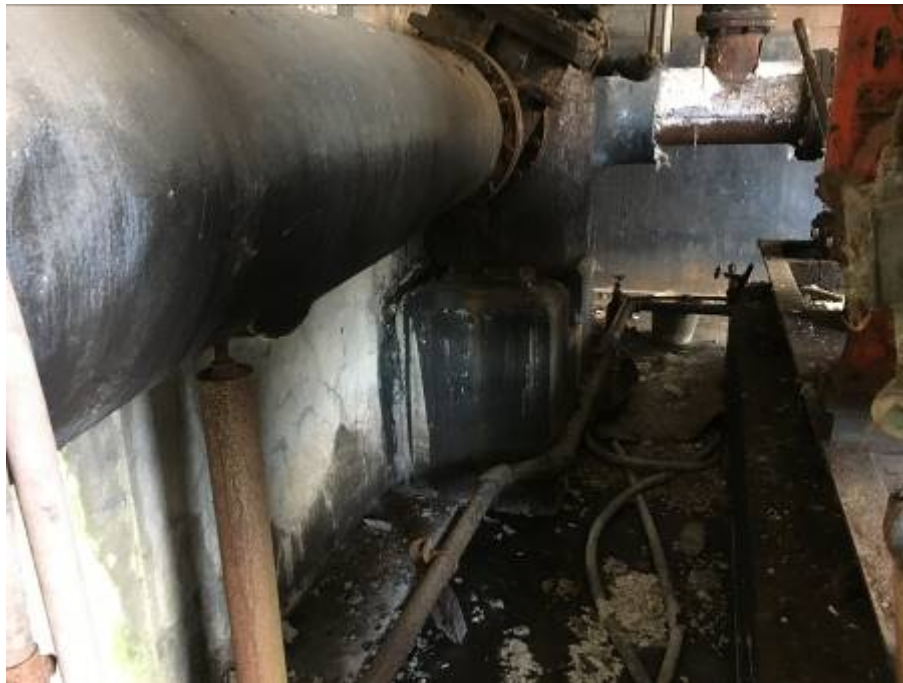
ACM pipe insulation debris on surfaces in many areas

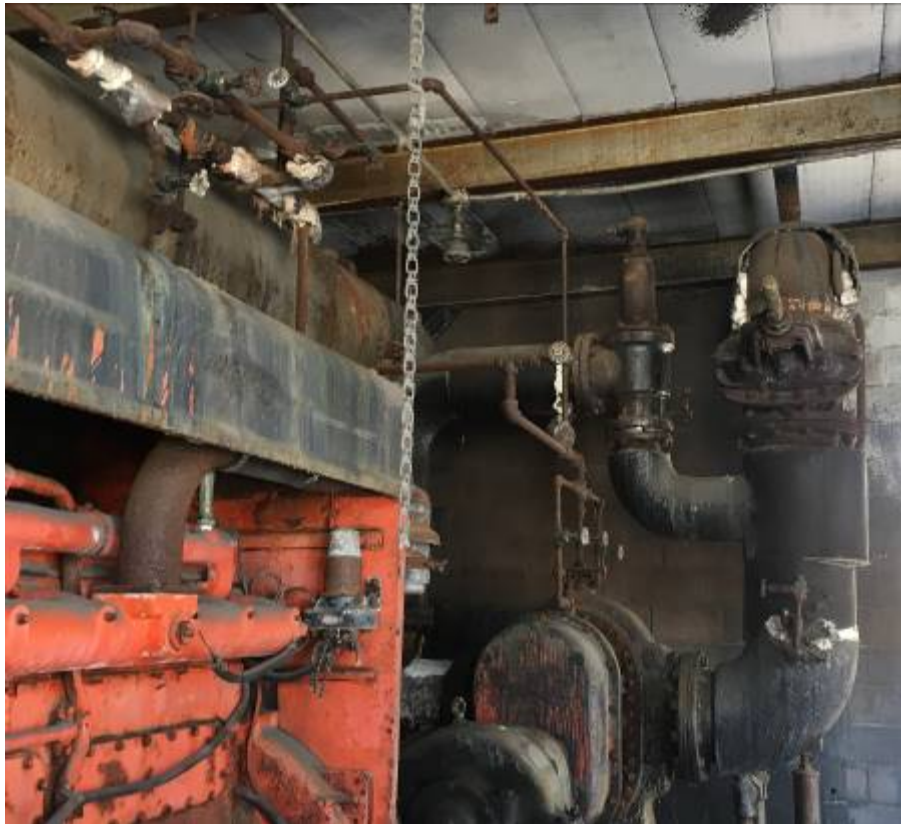
ACM pipe and fitting insulation in poor condition near ceiling and at pump

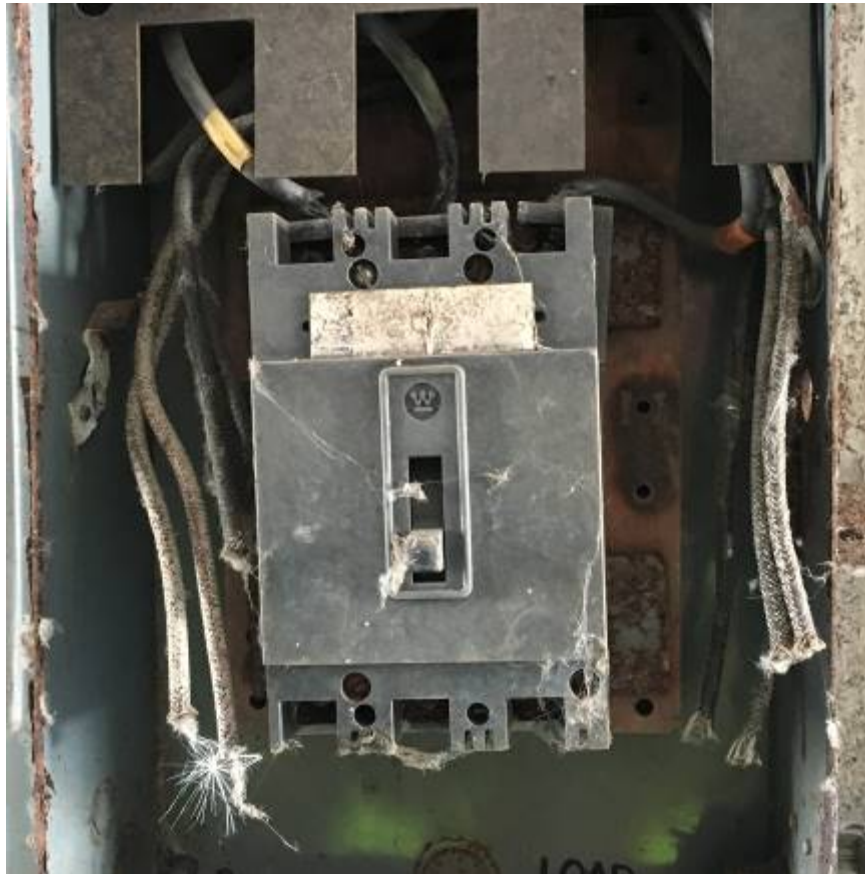
PACM cloth wrap on electrical wiring

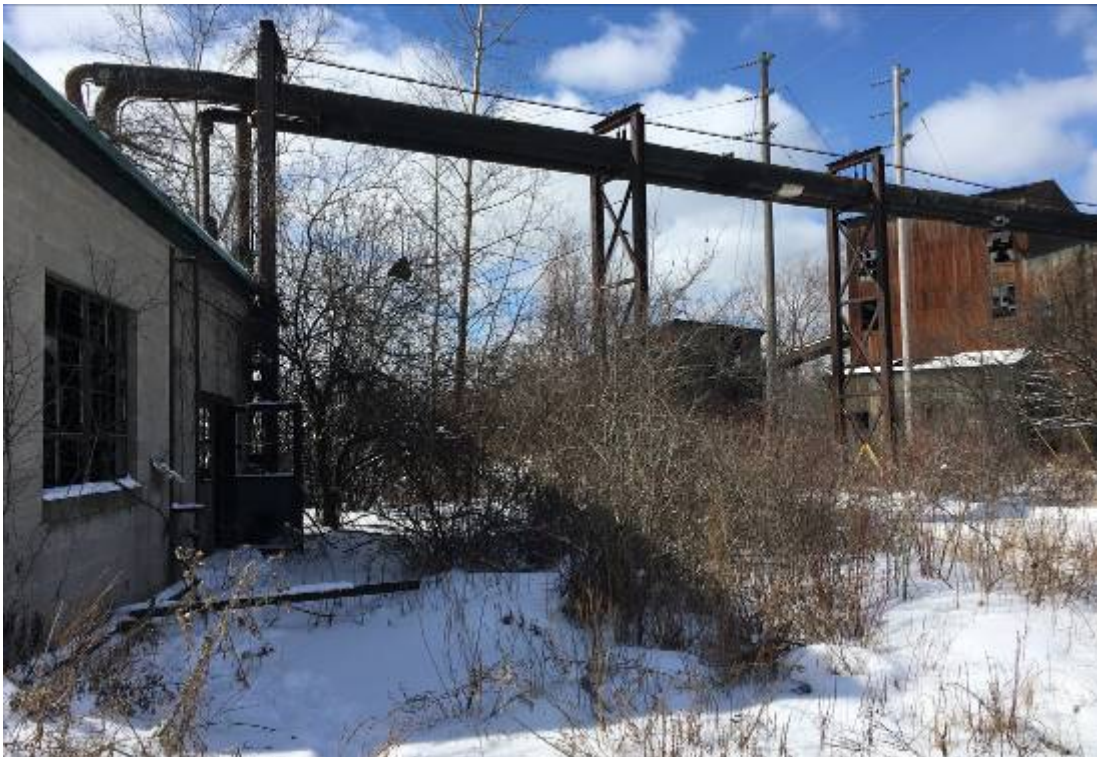
Exterior of building (at left) with ACM piping on overhead rack towards conveyor area
