Remedial Investigation Report

Riverview Innovation & Technology Campus
Brownfield Cleanup Program Site No. C915353

3875 River Road
Tonawanda, New York 14150

August 18, 2023

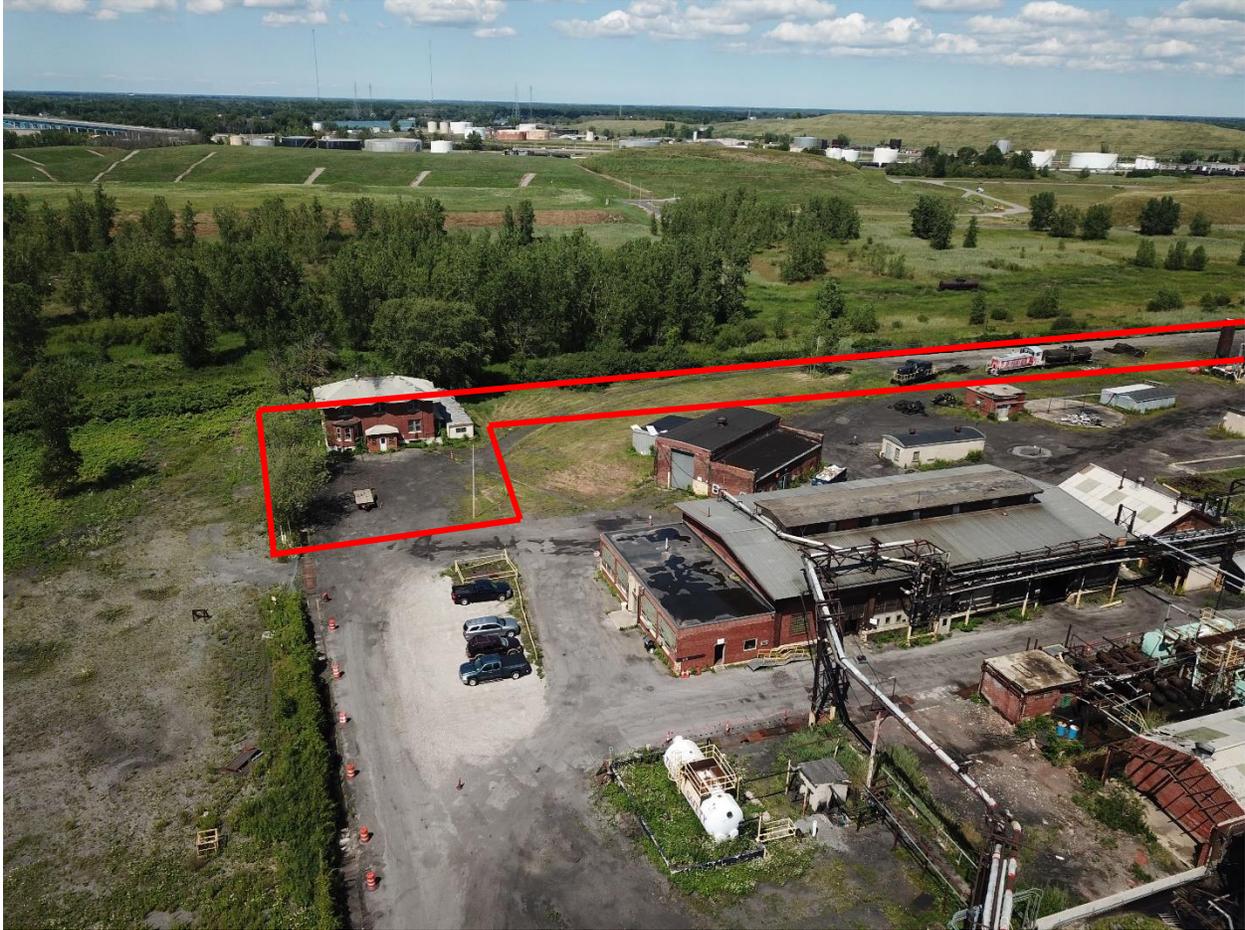
Photo 4-1: August 2020. Looking North. The redline approximates the west end of the North Rail Corridor (AOII).

Note: structures and equipment shown (Mansion, heavy equipment maintenance, oil house, welding shop, instrument shop, and locomotives) have been demolished/removed since date of photo.

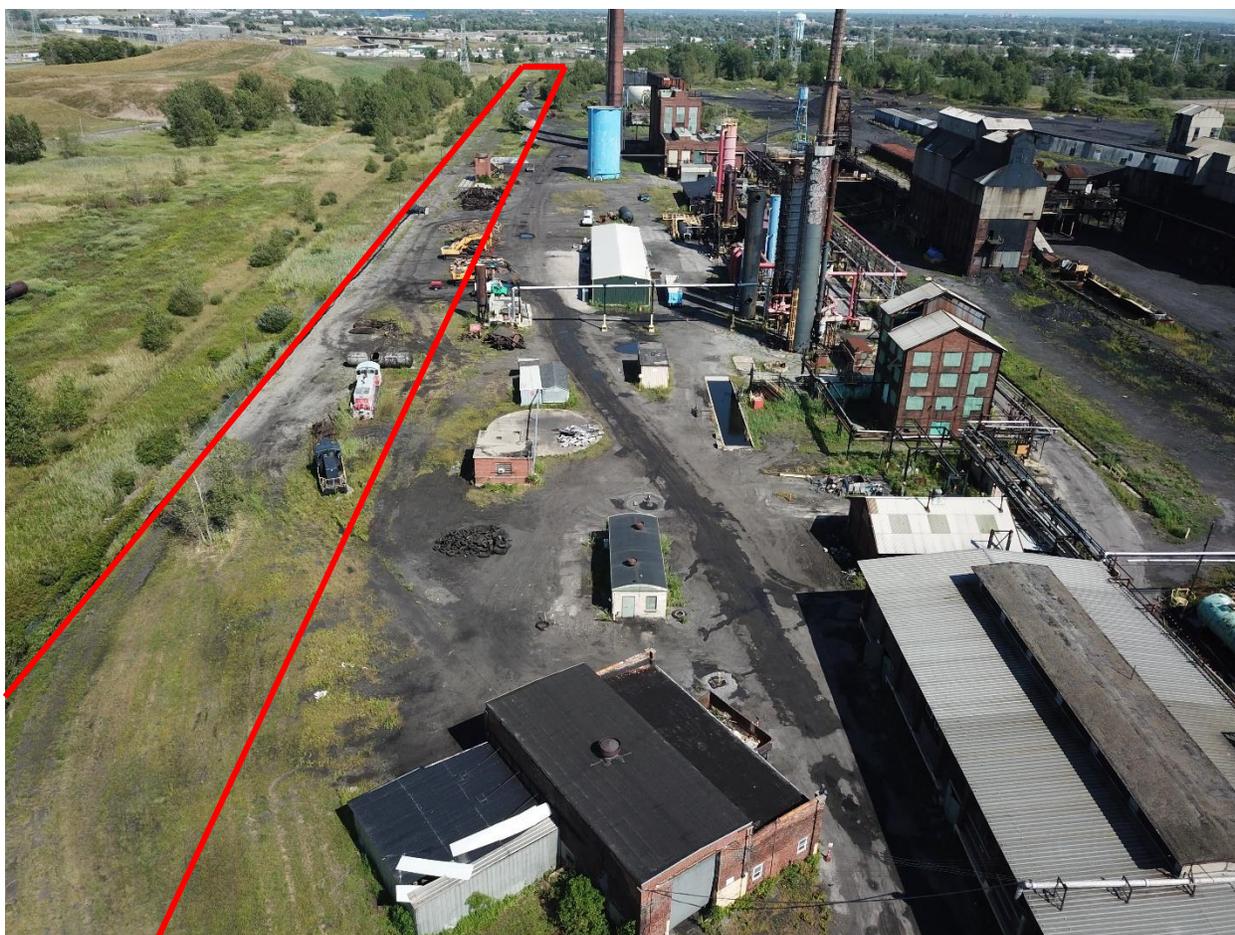
Photo 4-2: Looking east. August 2020. The redline approximates the northern, southern, and eastern limits of AOI1.

Note: structures and equipment shown have been demolished/removed since date of photo. No buildings or equipment remain in the North Rail Corridor.

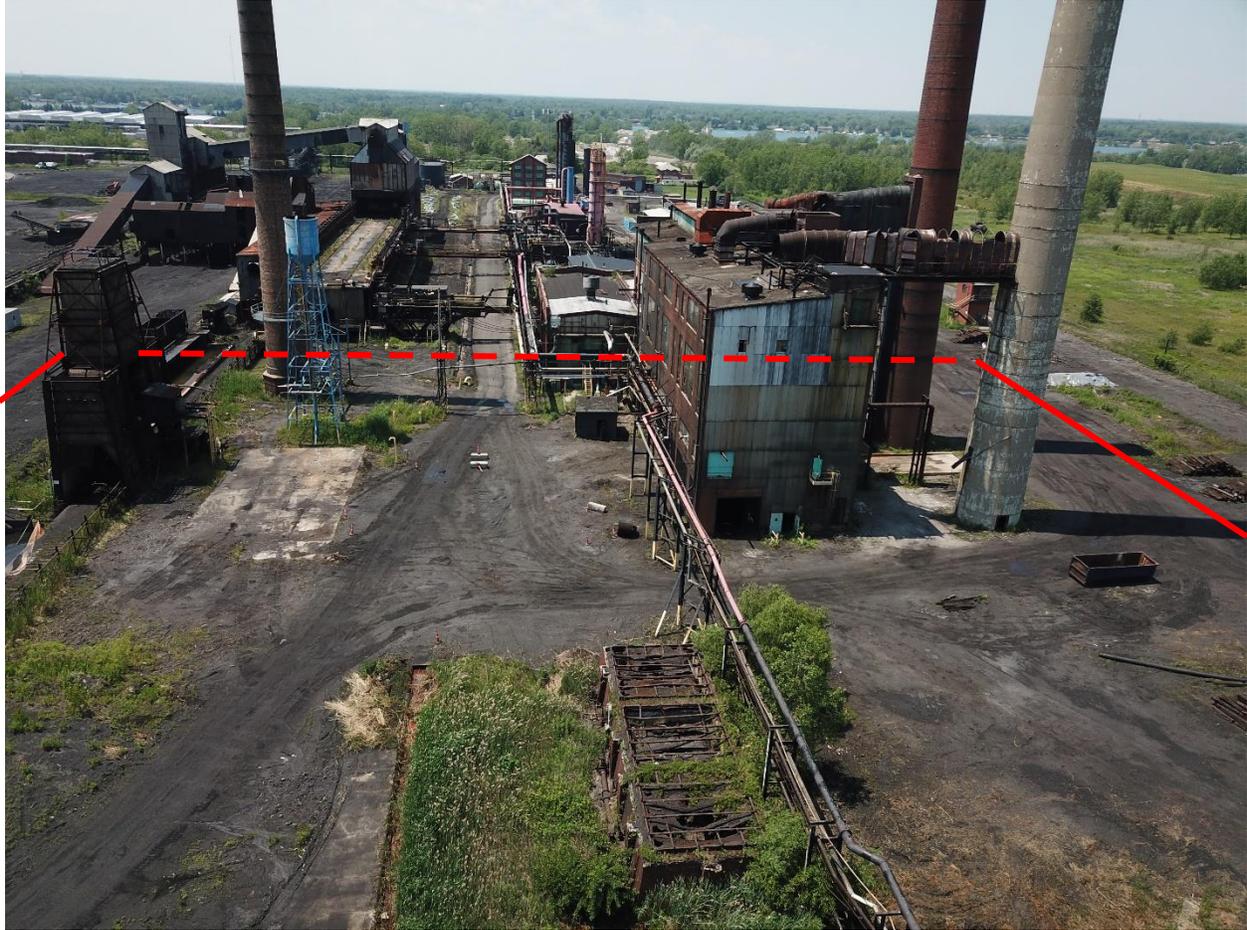
Photo 4-3: Looking west at a portion of AOI2 – Former Production Area East

Note: structures and equipment shown may have been demolished/removed since date of photo. Only the Purifier Box remains in AOI 2 East.

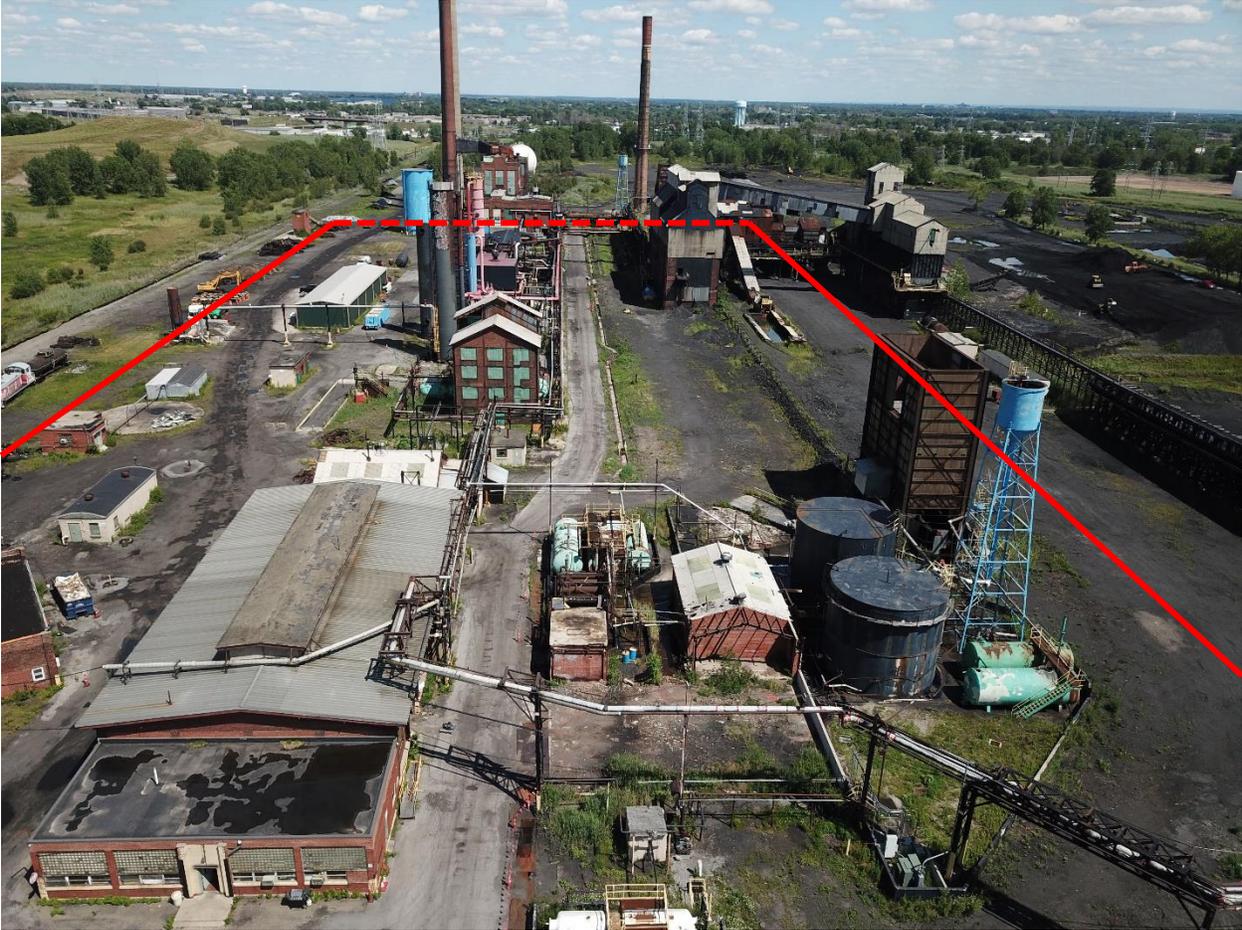
Photo 4-4: Looking east at a portion of AOI2 – Former Production Area West

Note: structures and equipment shown may have been demolished/removed since date of photo. Only the former Maintenance and machine shop in the lower left of the photograph remains.

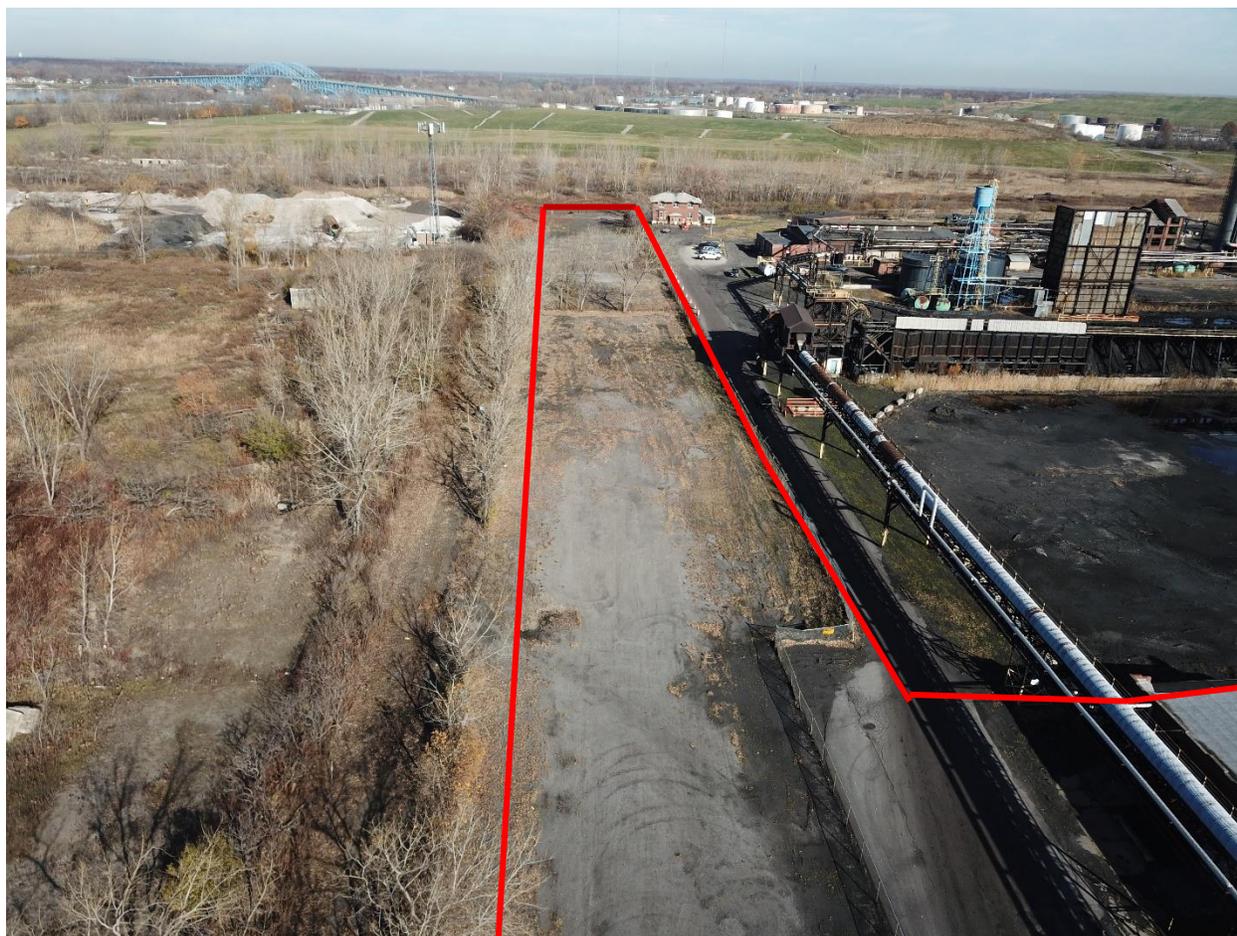
Photo 4-5: Looking north at northern section of the Parking Lot AOI.

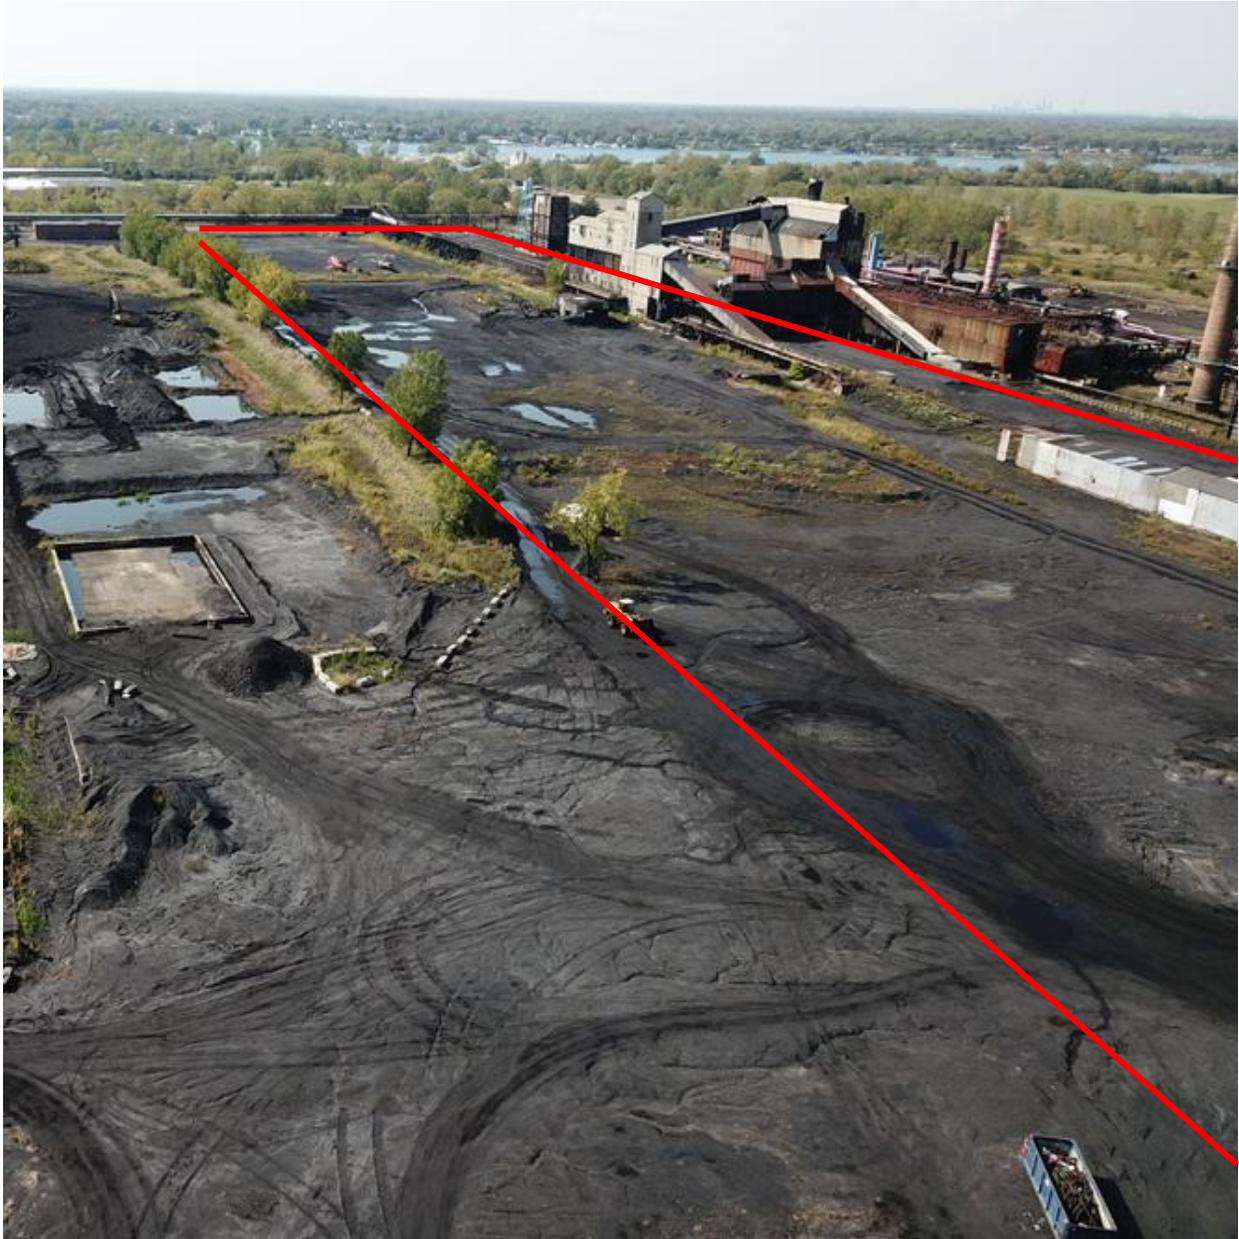
Photo 4-6: Looking Northwest Across the Coke Yard. The coal handling and coal charging buildings in the photograph were demolished in 2021

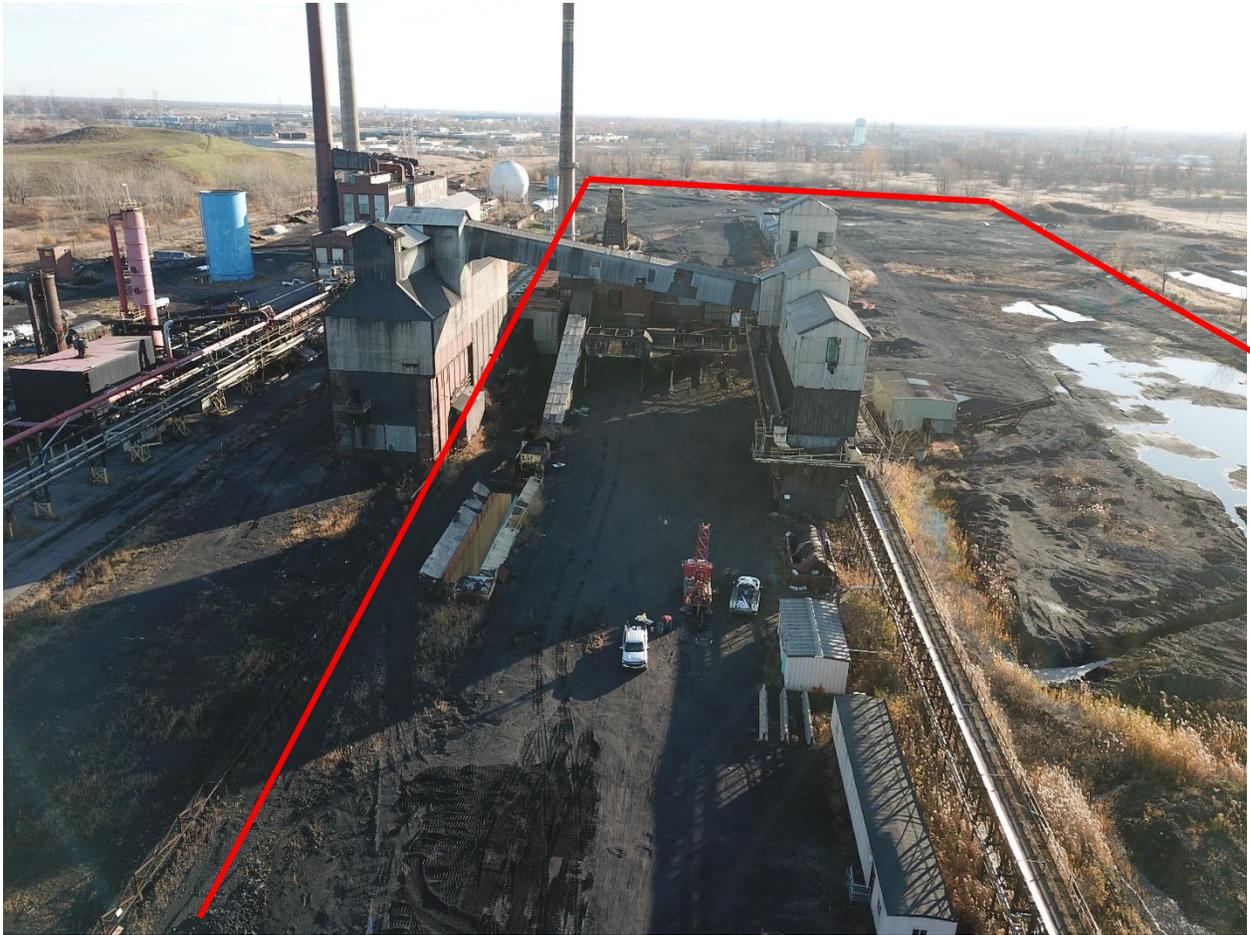
Photo 4-7: View Looking East Across Former Coke Rail Loading Yard (Northern Section of Coke Yard) in 2020.

Notes: All structures within the red boundary lines have been demolished.

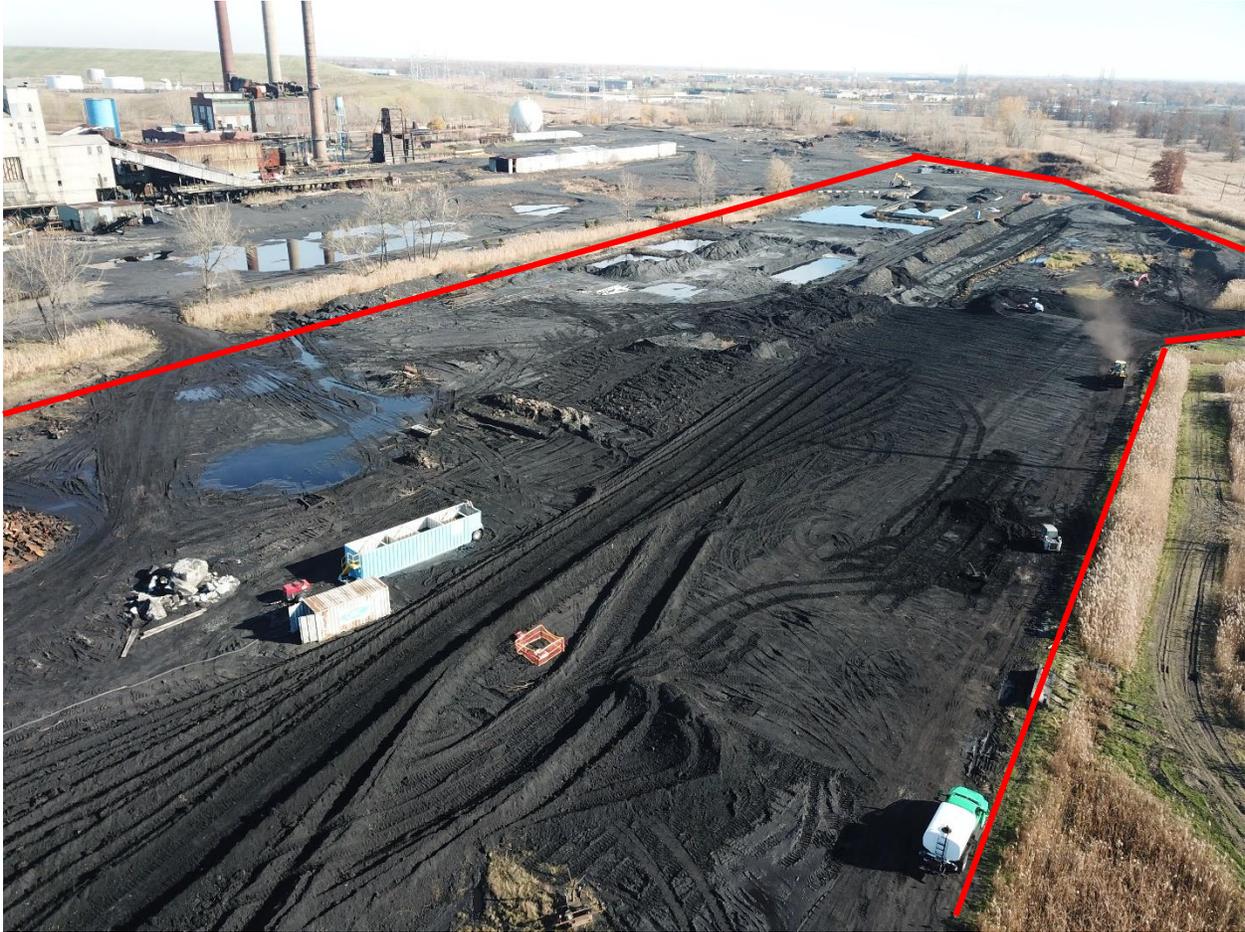
Photo 4-8: Looking Northeast across the Coal Yards during regrading and prior to establishing stormwater BMPs.

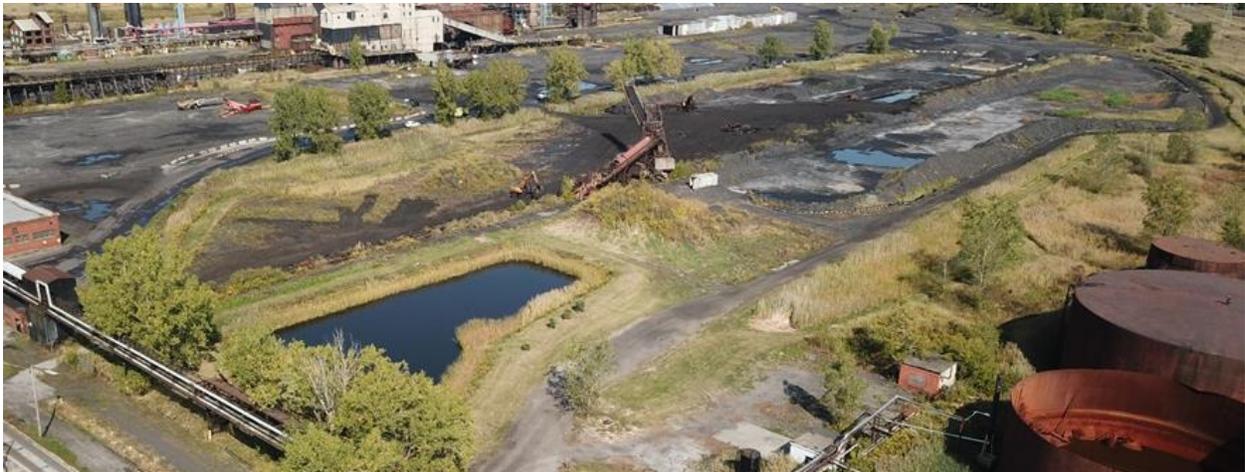
Photo 4-9: Looking Northeast at the coal yard before regrading and before removal of the stacker reclaimer (center of photo).

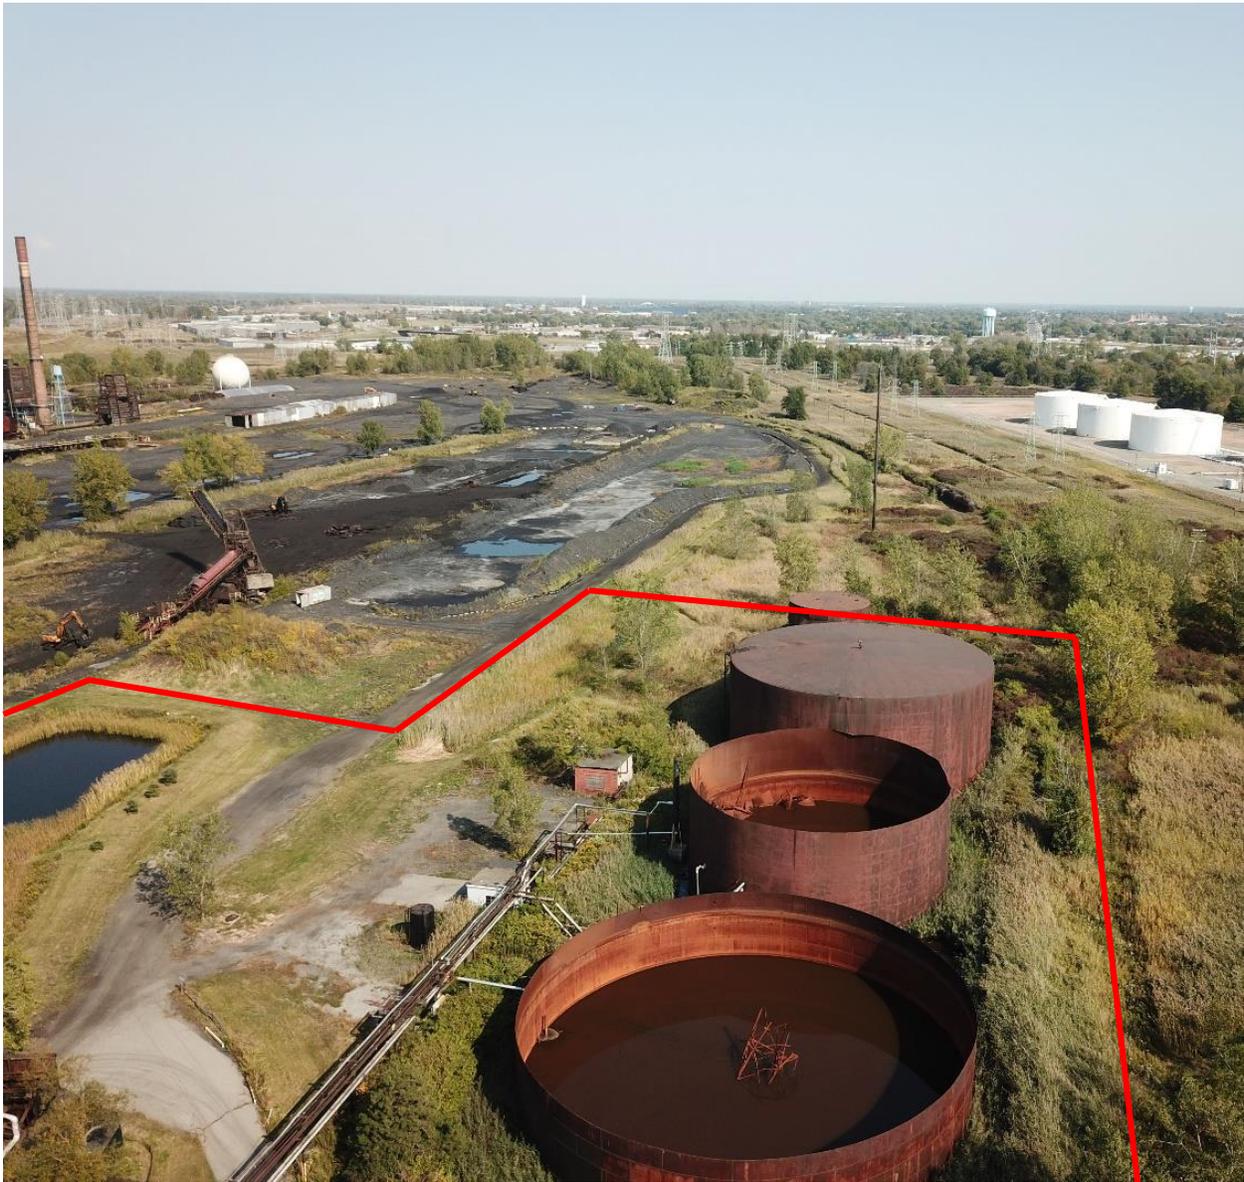
Photo 4-10: Looking northeast across the Water Treat AOI.

Notes: The photograph was taken before the surface impounding capacity in the coal yard was eliminated.

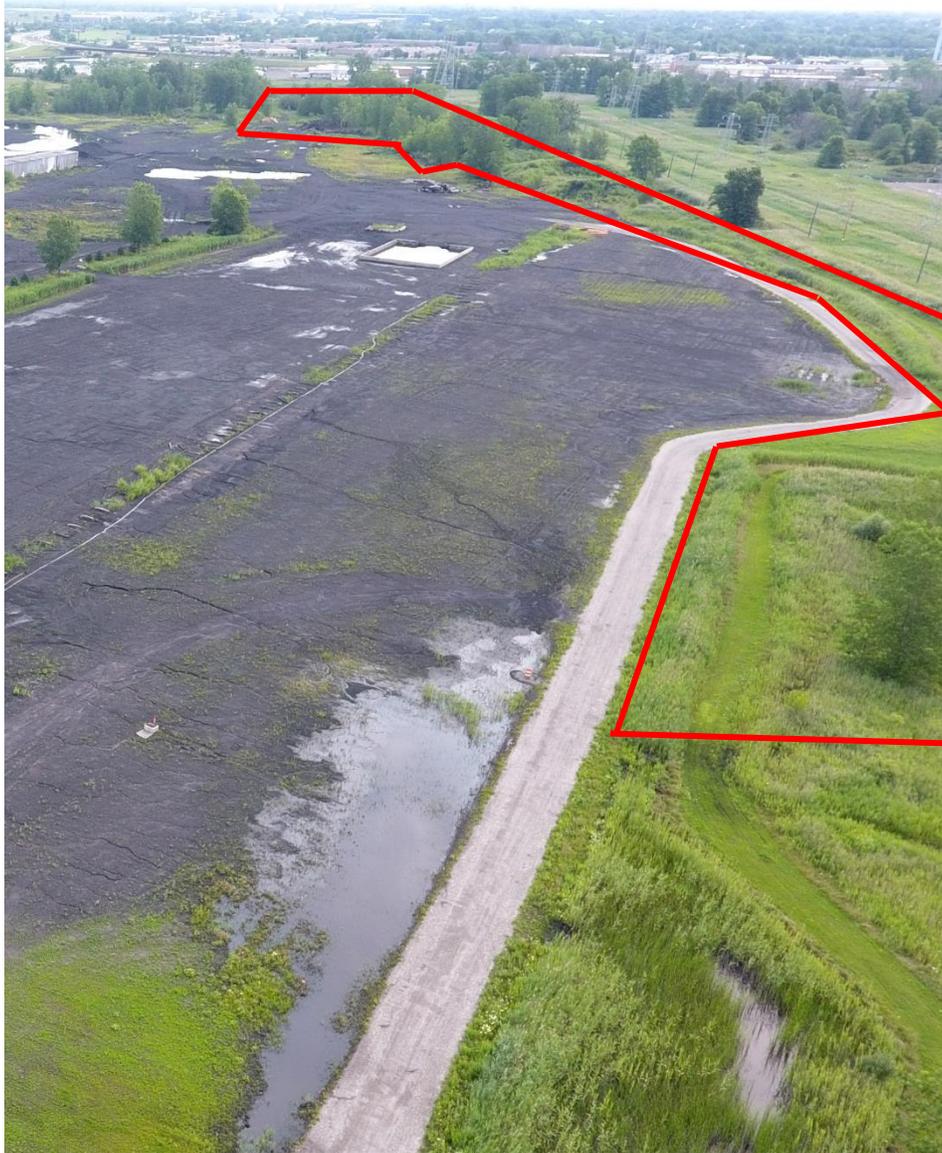
Photo 4-11: Looking east over the South Drainage AOI. Sedimentation Pool #001 is in the foreground of the photograph.

Note: This photograph was taken after the coal yard was regraded.

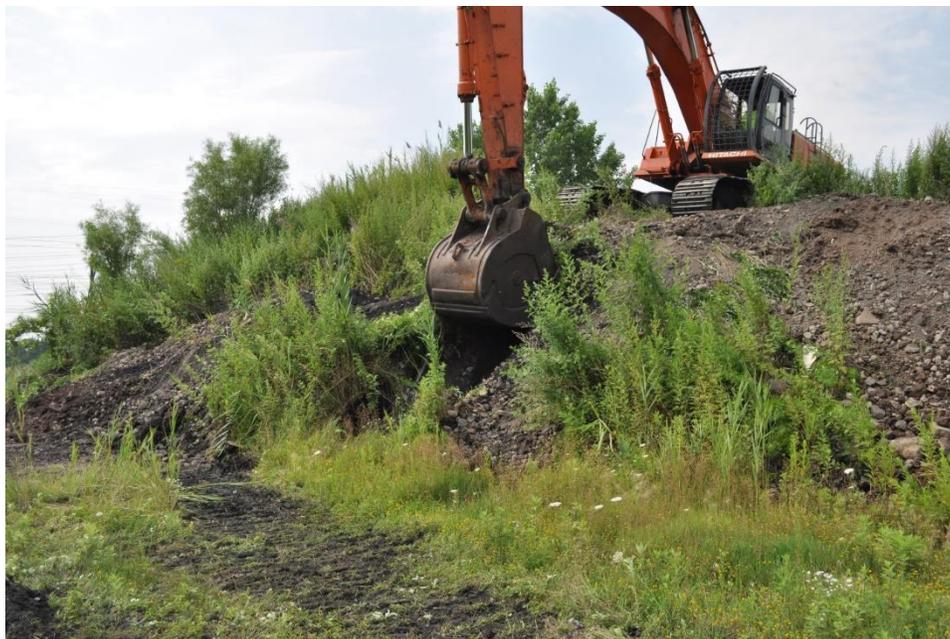
The South Drainage Area covers approximately 10.3 acres and is located along the southern boundary of the BCP Site south of the Coal Yard (AOI5) and Site 110. The eastern end of the AOI7 is bound by the National Grid high voltage power line right of way (to the east and south). No production processes are known to have occurred in this area but there were former rail lines, four abandoned rail cars (three have been removed, RC04 remains), and the South Ditch in this AOI. There are multiple large piles of fill and debris in the eastern section of this AOI.

Photograph 4-11 (closeup) – Fill piles at the eastern end of the South Ditch.

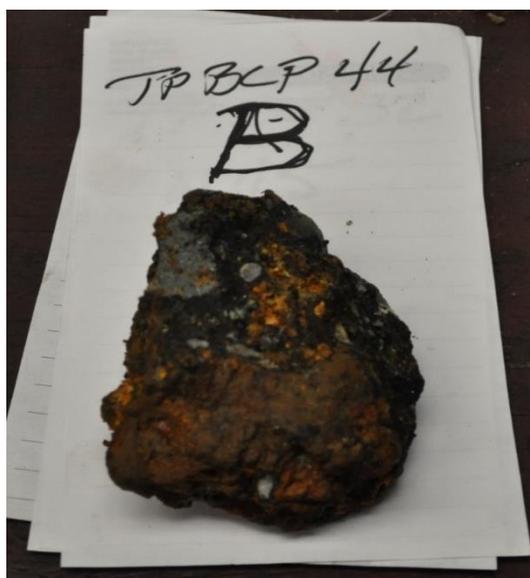
The rail and conveyor for the stacker reclaimer were removed. The conveyor foundations and the rail bed (densely compacted slag) remain between the north and south coal yards. This material was very different from the water bearing nodule materials that have the consistency and grain-size distribution of sandy gravel:

Photograph 4-16 – Slag Sample – TP-BCP-44
