**Remedial Investigation Report**

**Volume # 3 – Appendices A through D**

Riverview Innovation & Technology Campus

Brownfield Cleanup Program Site No. C915353

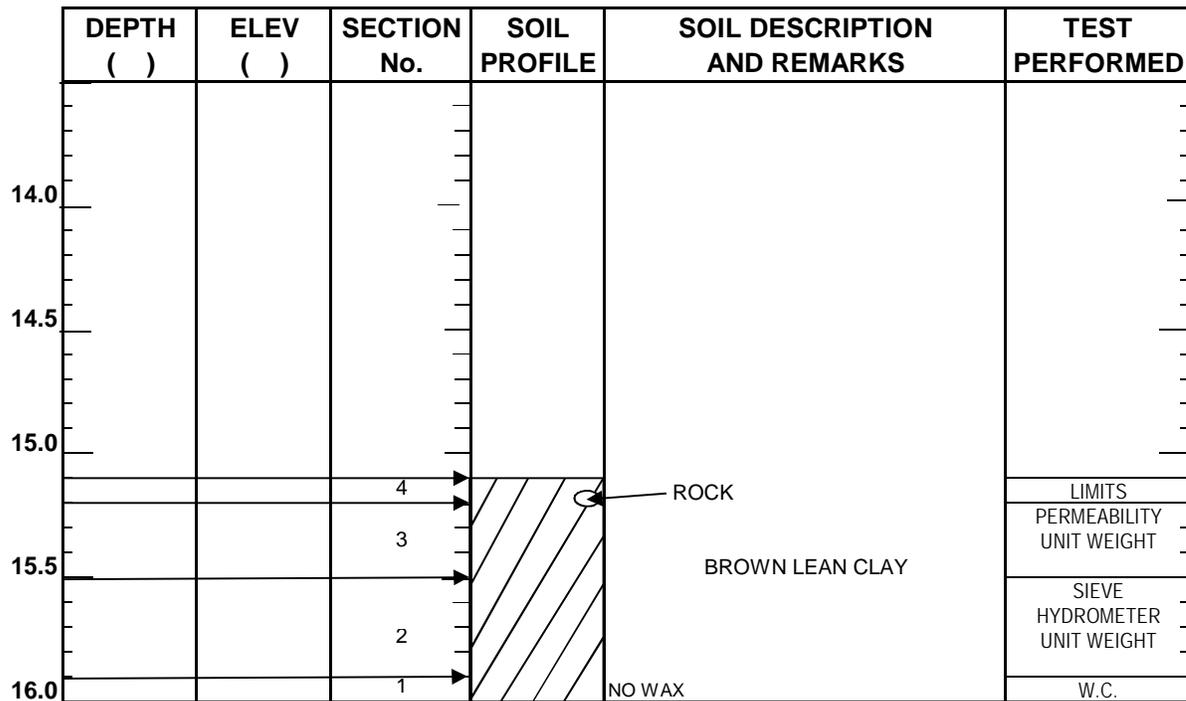
## SOIL PROFILE AND SAMPLING

*Note:* When full recovery is not achieved, the elevation can not be accurately defined.  
 Indicate each cut of the tube with an arrow.  
 Indicate dividing line between soil types with a solid line.  
 Indicate wax by cross-hatching. Indicate soil types by standard symbols.

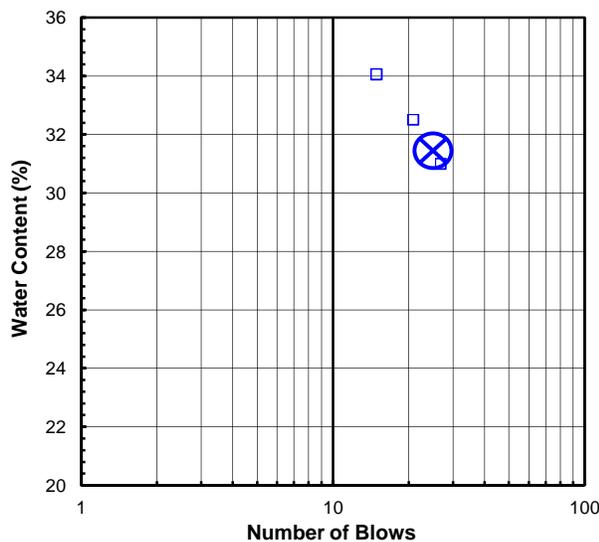
**Flow Curve**

As Received Moisture Content ASTM D2216-19	Liquid Limit Test				
	1	2	3	M	
Tare Number:	907	519	633	627	U
Wt. of Tare & Wet Sample (g):	292.23	39.92	39.60	41.74	L
Wt. of Tare & Dry Sample (g):	266.24	35.08	34.53	35.89	T
Weight of Tare (g):	110.23	19.45	18.92	18.70	I
Weight of Water (g):	26.0	4.8	5.1	5.9	P
Weight of Dry Sample (g):	156.0	15.6	15.6	17.2	O
Was As Received MC Preserved:	<b>Yes</b>				I
<b>Moisture Content (%):</b>	<b>16.7</b>	<b>31.0</b>	<b>32.5</b>	<b>34.0</b>	<b>N</b>
<b>Number of Blows:</b>		<b>27</b>	<b>21</b>	<b>15</b>	<b>T</b>

Plastic Limit Test	1	2	Range	Test Results
Tare Number:	115	1273		<b>Liquid Limit (%):</b> <b>31</b>
Wt. of Tare & Wet Sample (g):	25.52	27.94		<b>Plastic Limit (%):</b> <b>16</b>
Wt. of Tare & Dry Sample (g):	24.62	27.10		<b>Plasticity Index (%):</b> <b>15</b>
Weight of Tare (g):	19.18	21.89		<b>USCS Symbol:</b> <b>CL</b>
Weight of Water (g):	0.9	0.8		
Weight of Dry Sample (g):	5.4	5.2		
<b>Moisture Content (%):</b>	<b>16.5</b>	<b>16.1</b>	<b>0.4</b>	
<i>Note: The acceptable range of the two Moisture Contents is <math>\pm</math></i>				1.12

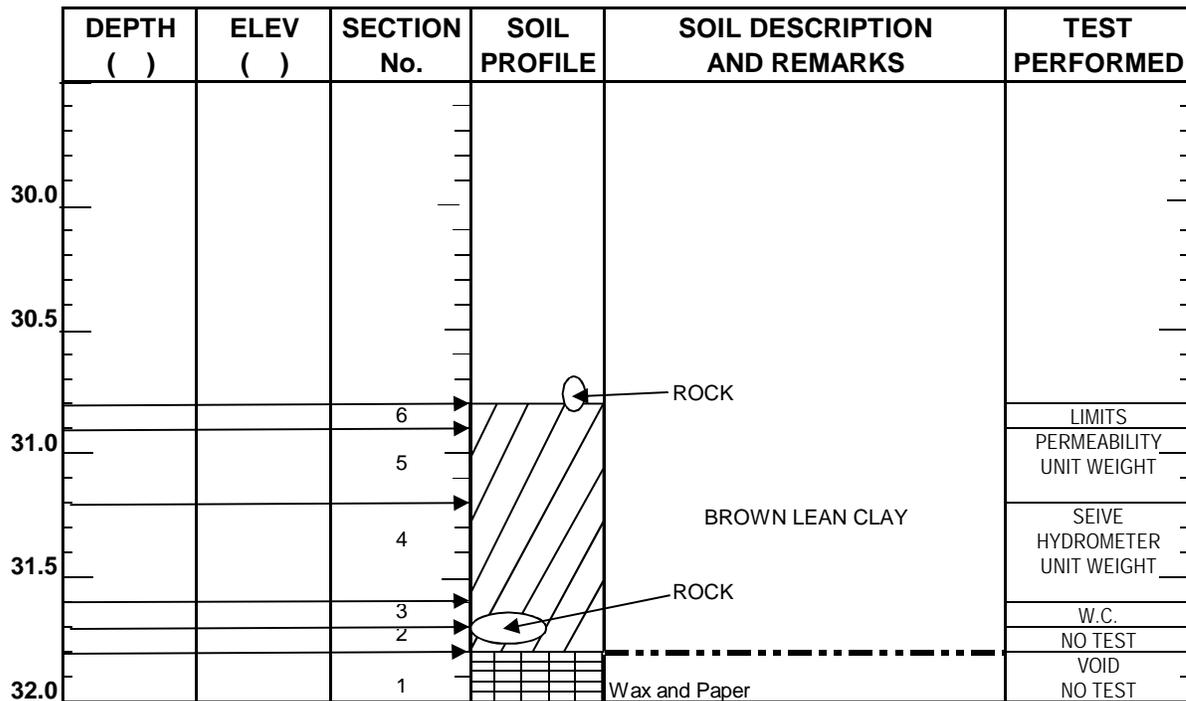
## SOIL PROFILE AND SAMPLING

*Note:* When full recovery is not achieved, the elevation can not be accurately defined.  
 Indicate each cut of the tube with an arrow.  
 Indicate dividing line between soil types with a solid line.  
 Indicate wax by cross-hatching. Indicate soil types by standard symbols.

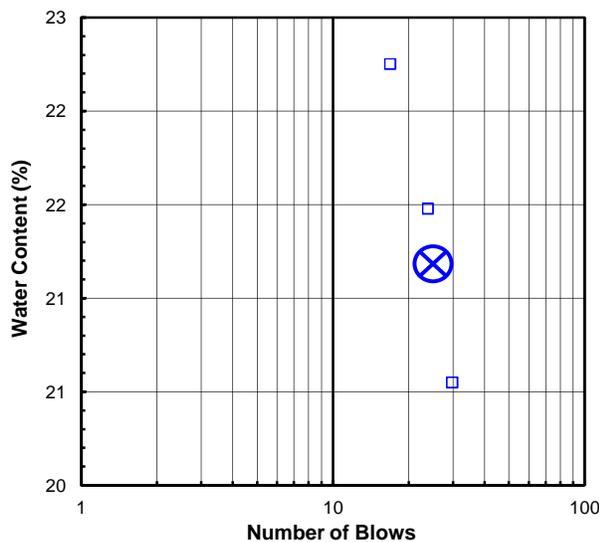
Flow Curve

As Received Moisture Content ASTM D2216-19	Liquid Limit Test				
	1	2	3	M	
Tare Number:	897	229	294	346	U
Wt. of Tare & Wet Sample (g):	263.38	38.55	44.44	42.17	L
Wt. of Tare & Dry Sample (g):	233.38	35.08	40.65	38.23	T
Weight of Tare (g):	109.26	18.19	23.00	20.52	I
Weight of Water (g):	30.0	3.5	3.8	3.9	P
Weight of Dry Sample (g):	124.1	16.9	17.7	17.7	O
Was As Received MC Preserved:	<b>Yes</b>				I
<b>Moisture Content (%):</b>	<b>24.2</b>	<b>20.5</b>	<b>21.5</b>	<b>22.2</b>	<b>N</b>
<b>Number of Blows:</b>	<b>30</b>	<b>24</b>	<b>17</b>		<b>T</b>

Plastic Limit Test	1	2	Range	Test Results
Tare Number:	15	319		<b>Liquid Limit (%):</b> 21
Wt. of Tare & Wet Sample (g):	24.16	24.53		<b>Plastic Limit (%):</b> 12
Wt. of Tare & Dry Sample (g):	23.45	23.90		<b>Plasticity Index (%):</b> 9
Weight of Tare (g):	17.55	18.27		<b>USCS Symbol:</b> CL
Weight of Water (g):	0.7	0.6		
Weight of Dry Sample (g):	5.9	5.6		
<b>Moisture Content (%):</b>	<b>12.0</b>	<b>11.2</b>	<b>0.8</b>	
<i>Note: The acceptable range of the two Moisture Contents is <math>\pm</math></i>				1.12

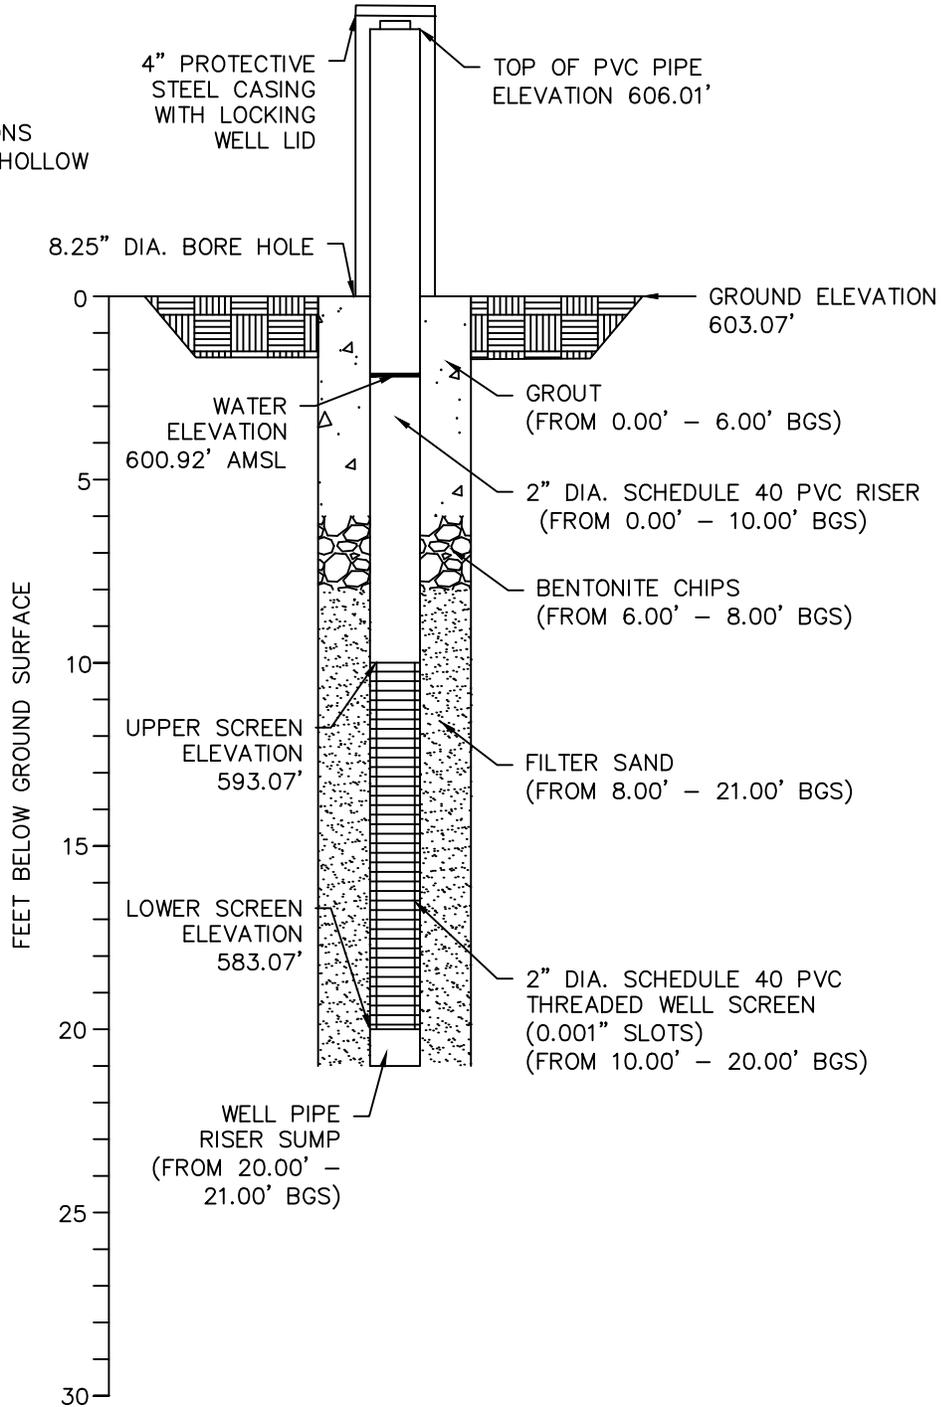
WELL ID: MW-BCP-01B  
 DRAWING NUMBER  
 D-101

DRILLER: EARTH DIMENSIONS  
 DRILLING METHOD: 4.25" HOLLOW  
 STEM AUGER

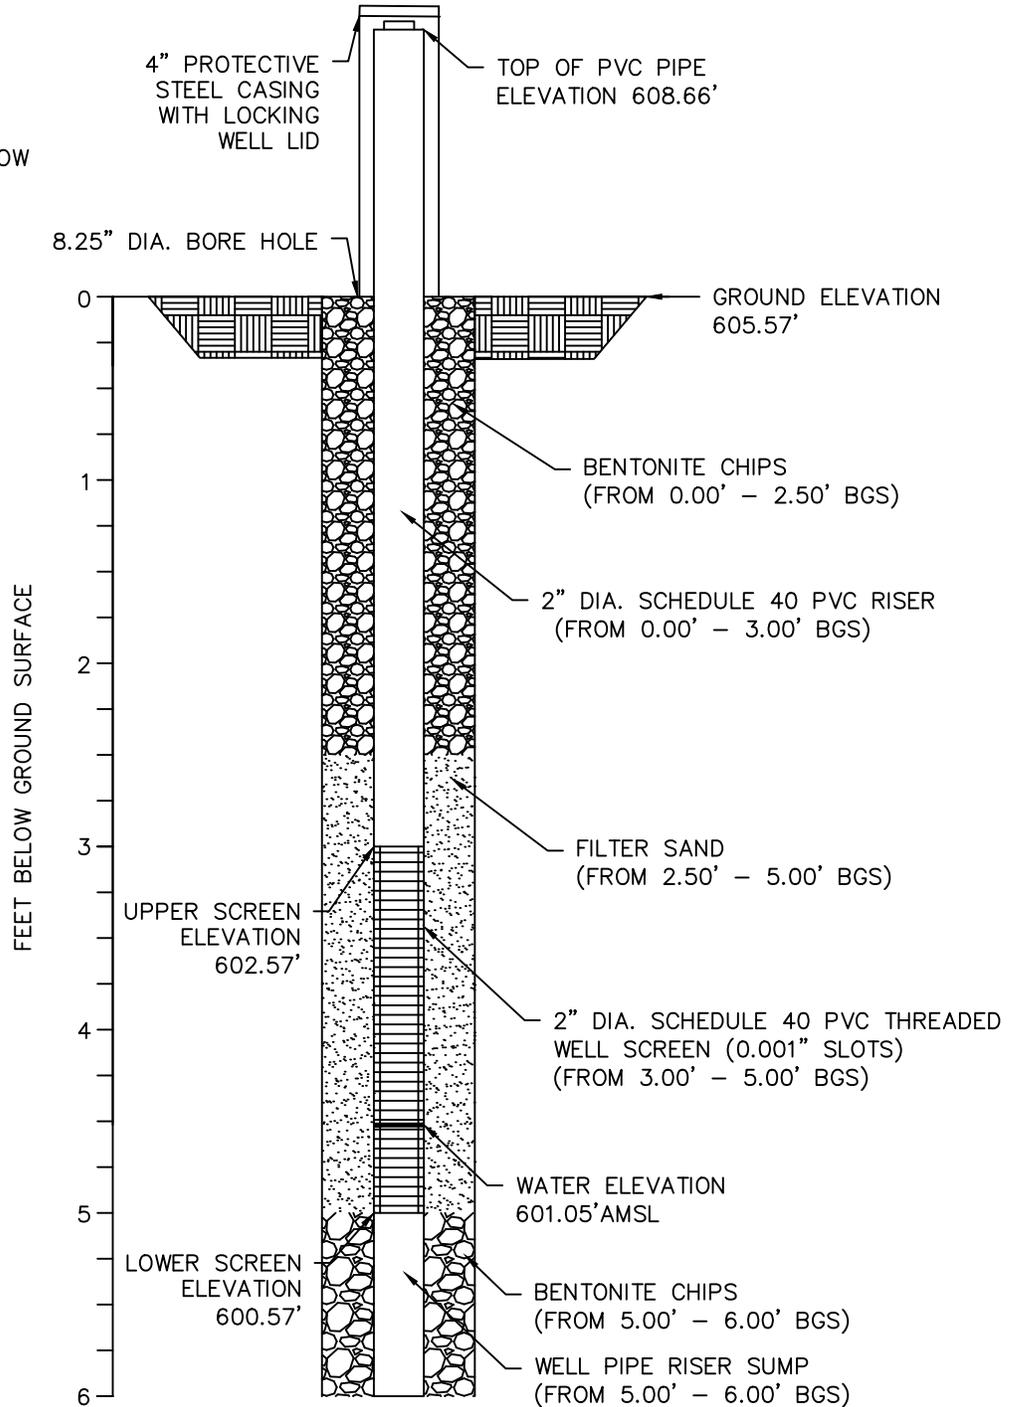
WELL ID: MW-BCP-02A  
 DRAWING NUMBER  
 D-103

DRILLER: EARTH DIMENSIONS  
 DRILLING METHOD: 4.25" HOLLOW  
 STEM AUGER

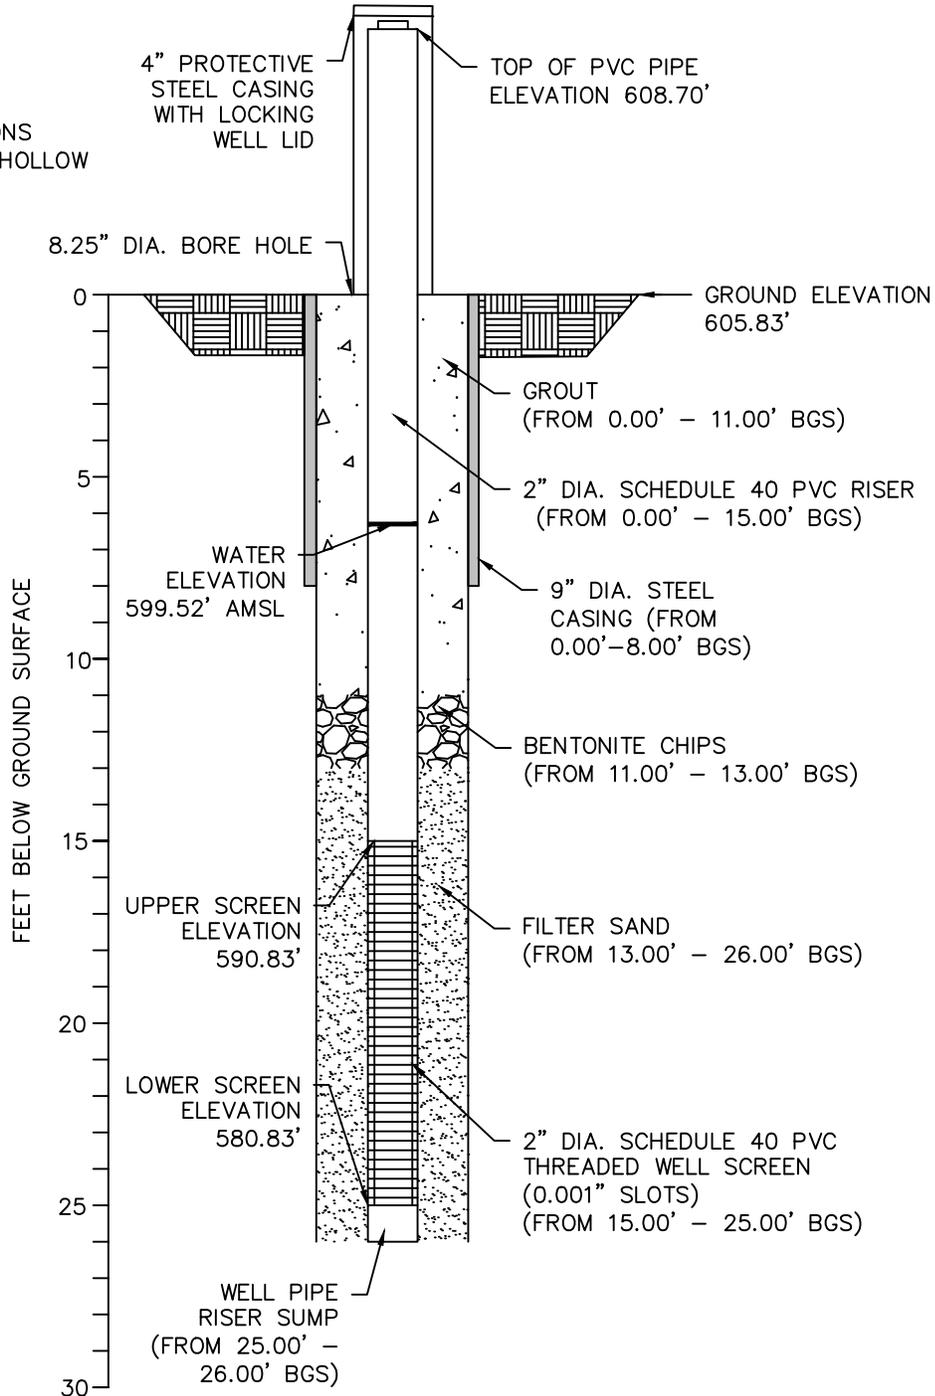
WELL ID: MW-BCP-02B  
 DRAWING NUMBER  
 D-104

DRILLER: EARTH DIMENSIONS  
 DRILLING METHOD: 4.25" HOLLOW  
 STEM AUGER

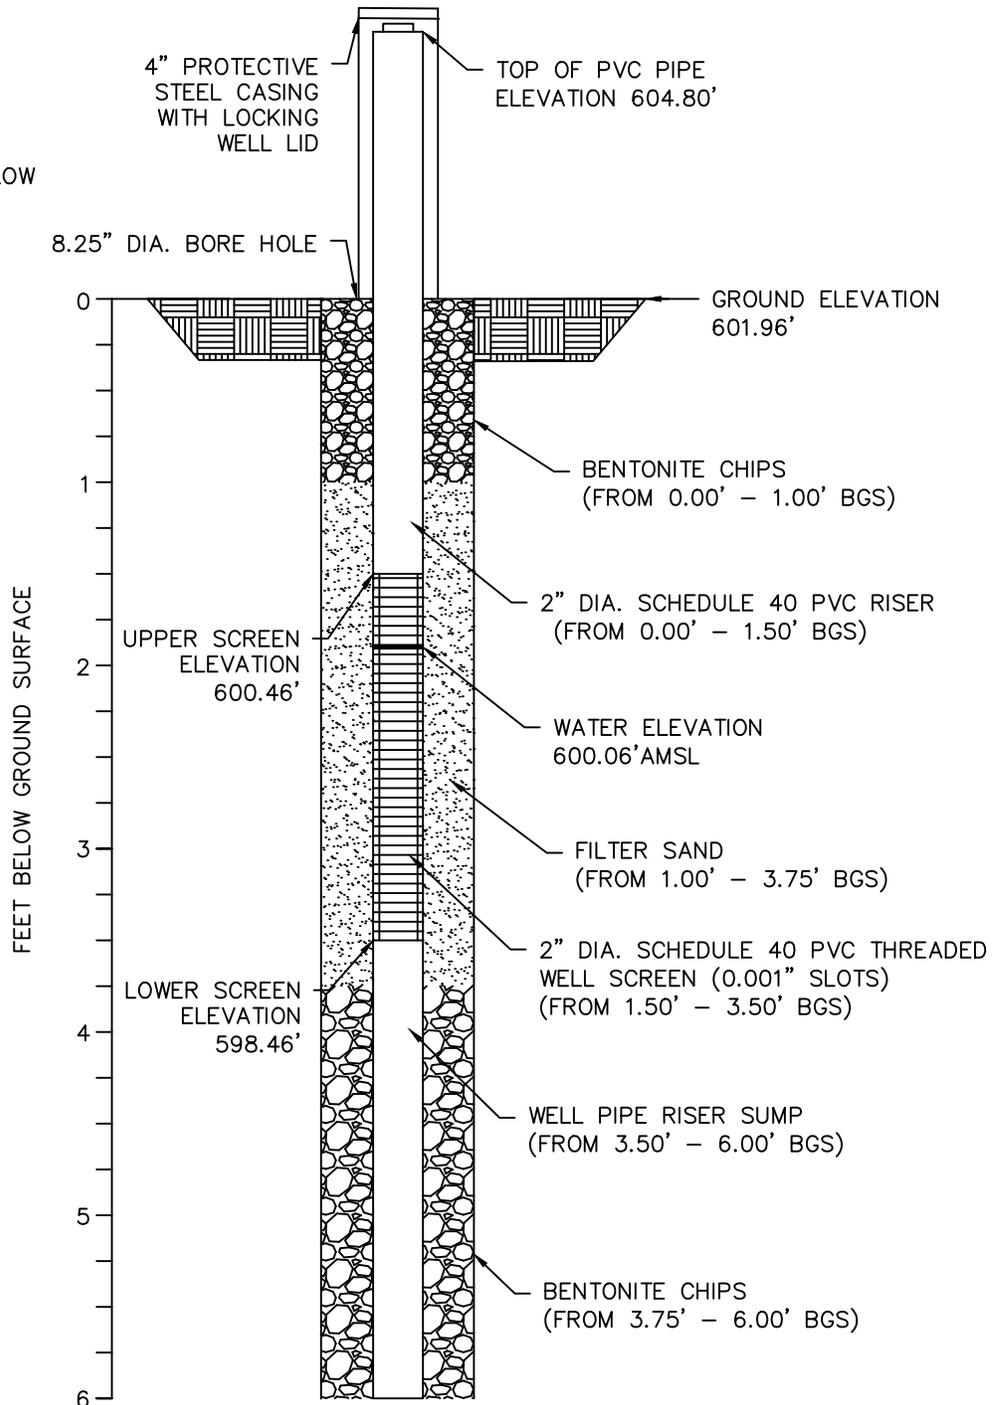
WELL ID: MW-BCP-03A  
 DRAWING NUMBER  
 D-105

DRILLER: EARTH DIMENSIONS  
 DRILLING METHOD: 4.25" HOLLOW  
 STEM AUGER

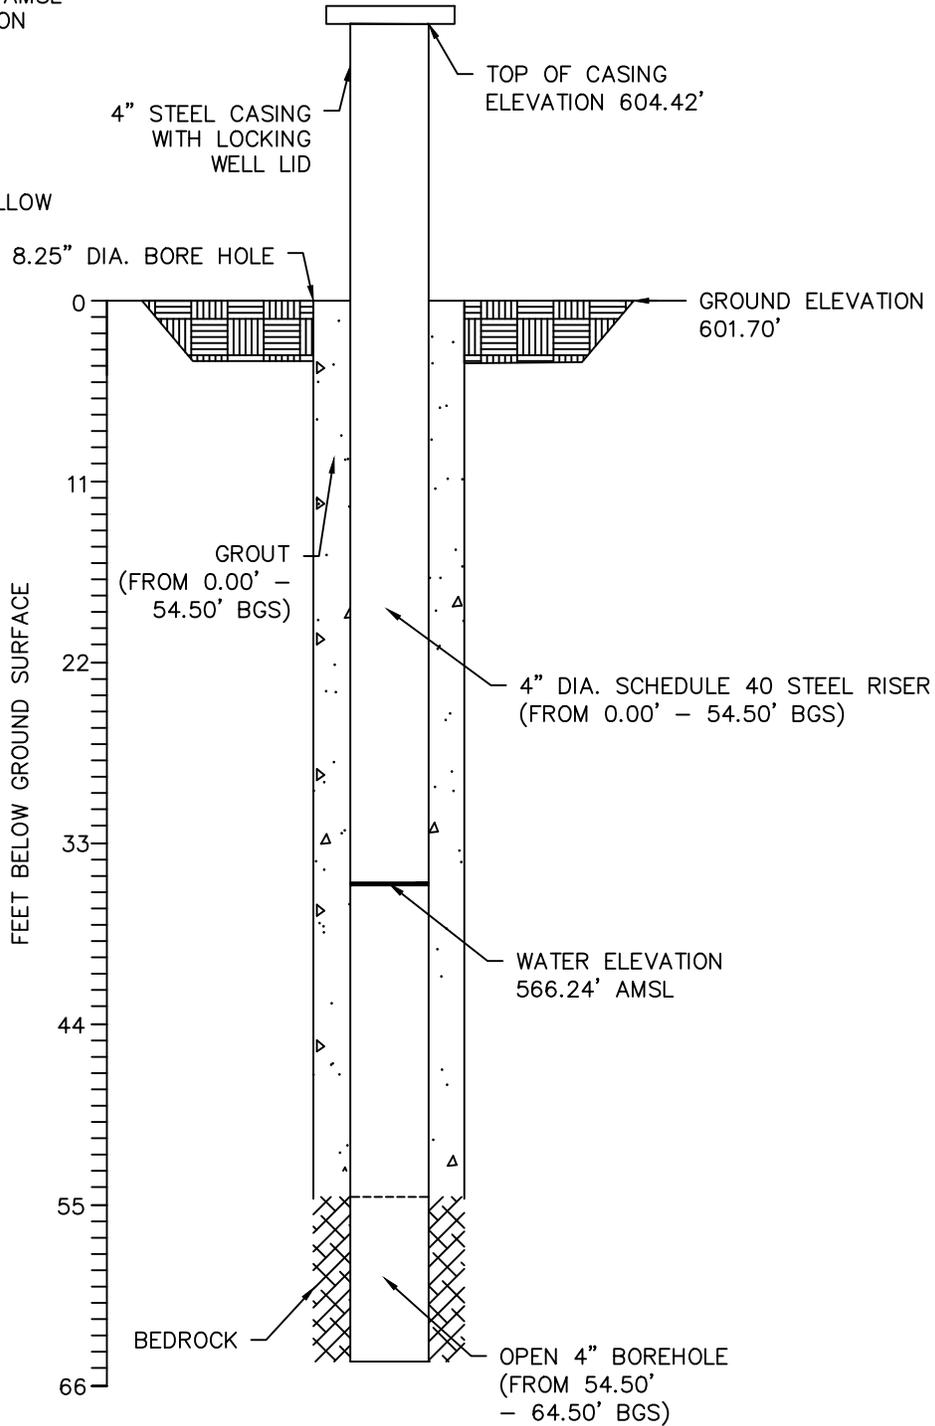
WELL ID: MW-BCP-03C  
 DRAWING NUMBER  
 D-107

DRILLER: EARTH DIMENSIONS  
 DRILLING METHOD: 4.25" HOLLOW  
 STEM AUGER

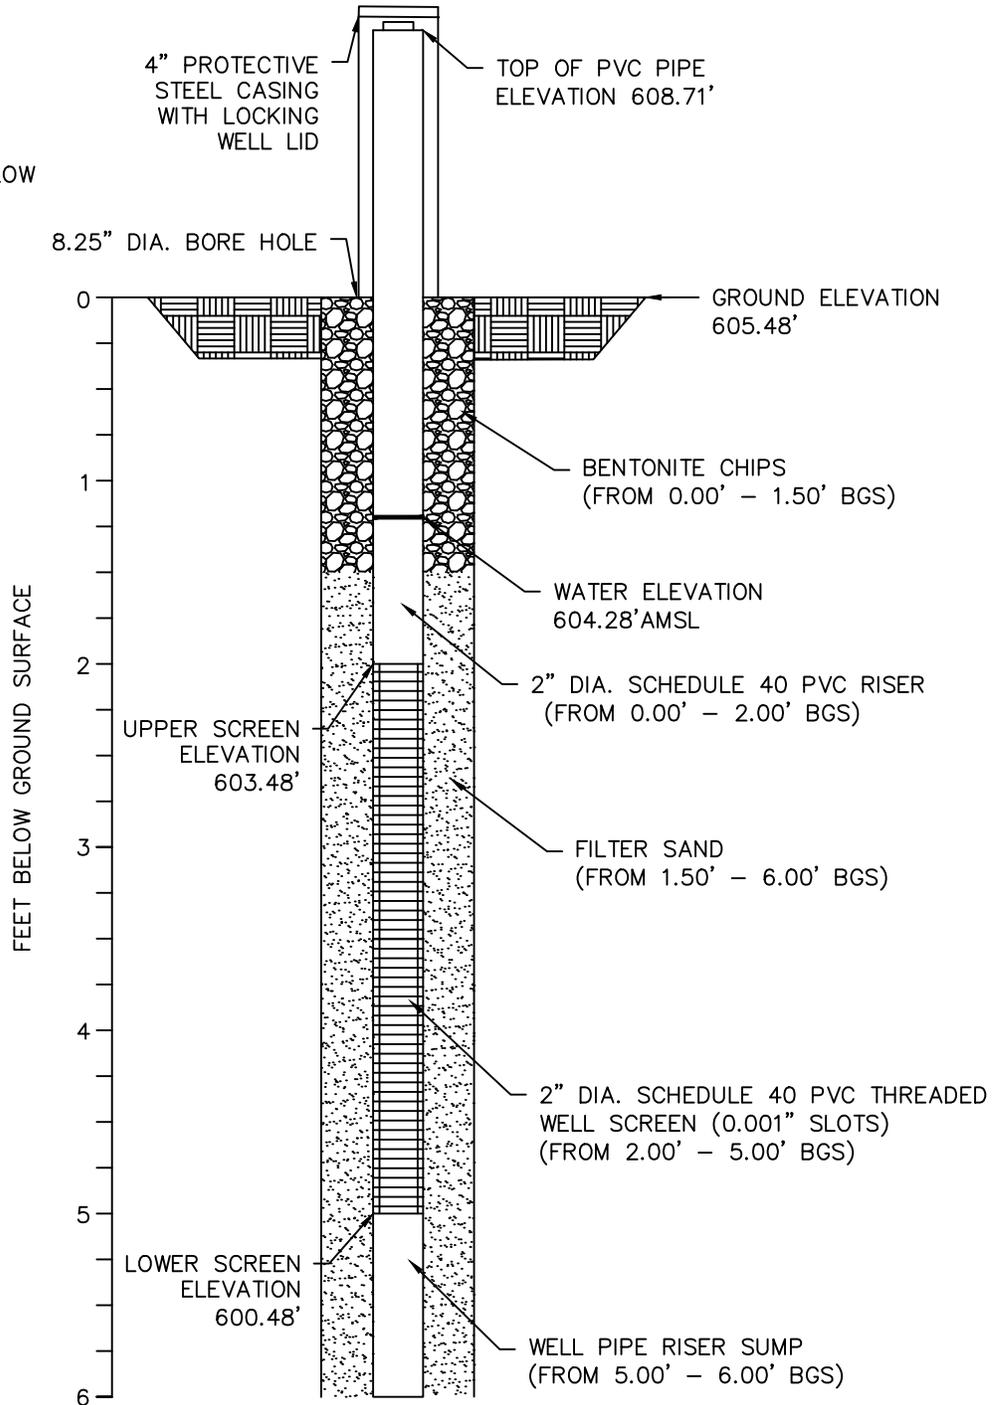
WELL ID: MW-BCP-04A  
 DRAWING NUMBER  
 D-108

DRILLER: EARTH DIMENSIONS  
 DRILLING METHOD: 4.25" HOLLOW  
 STEM AUGER

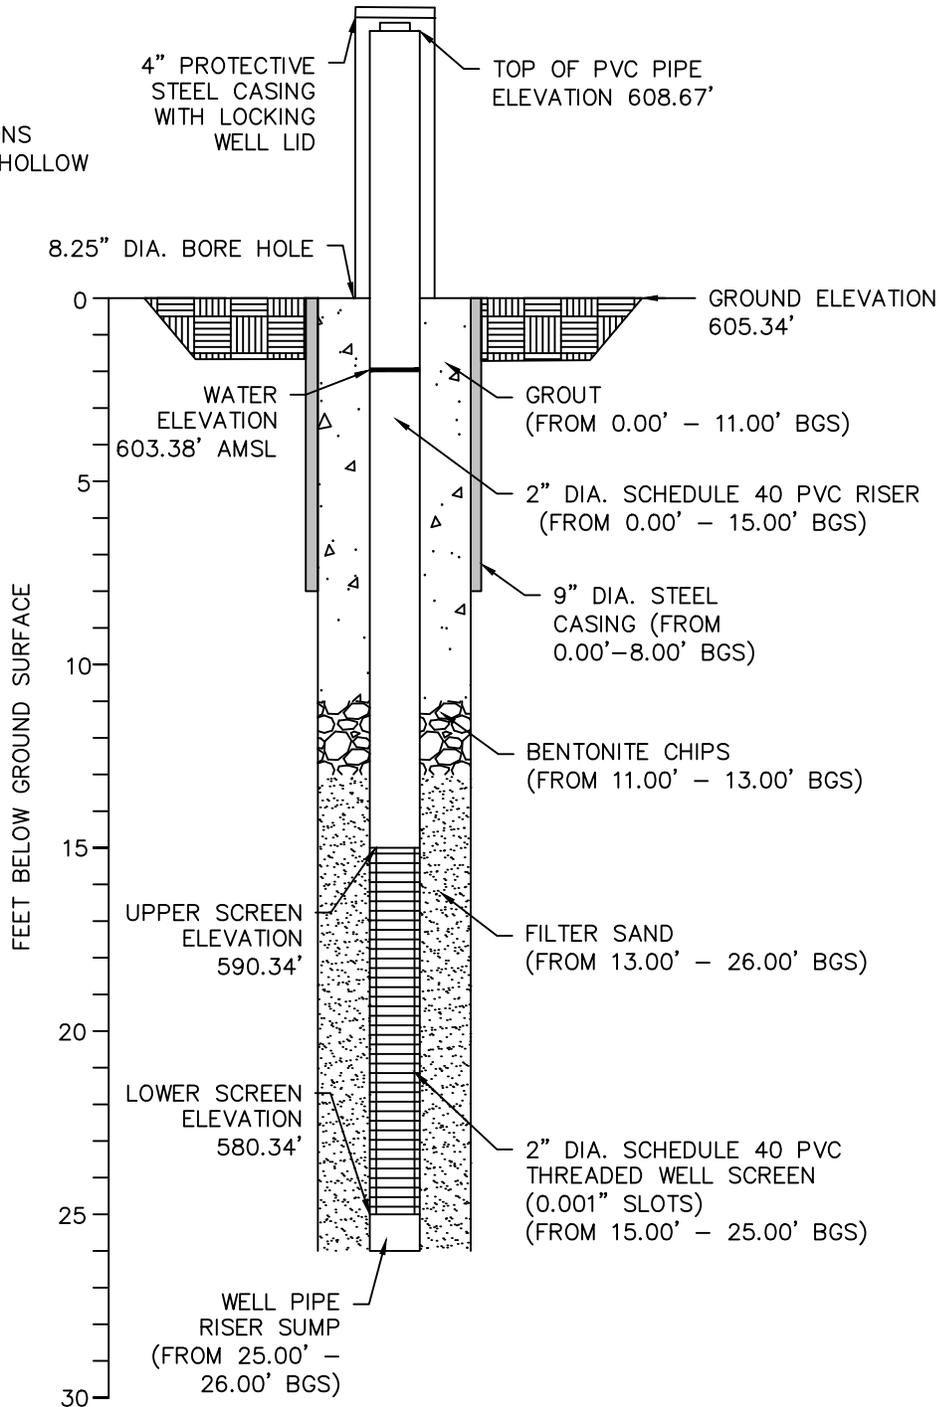
WELL ID: MW-BCP-04B  
 DRAWING NUMBER  
 D-109

DRILLER: EARTH DIMENSIONS  
 DRILLING METHOD: 4.25" HOLLOW  
 STEM AUGER

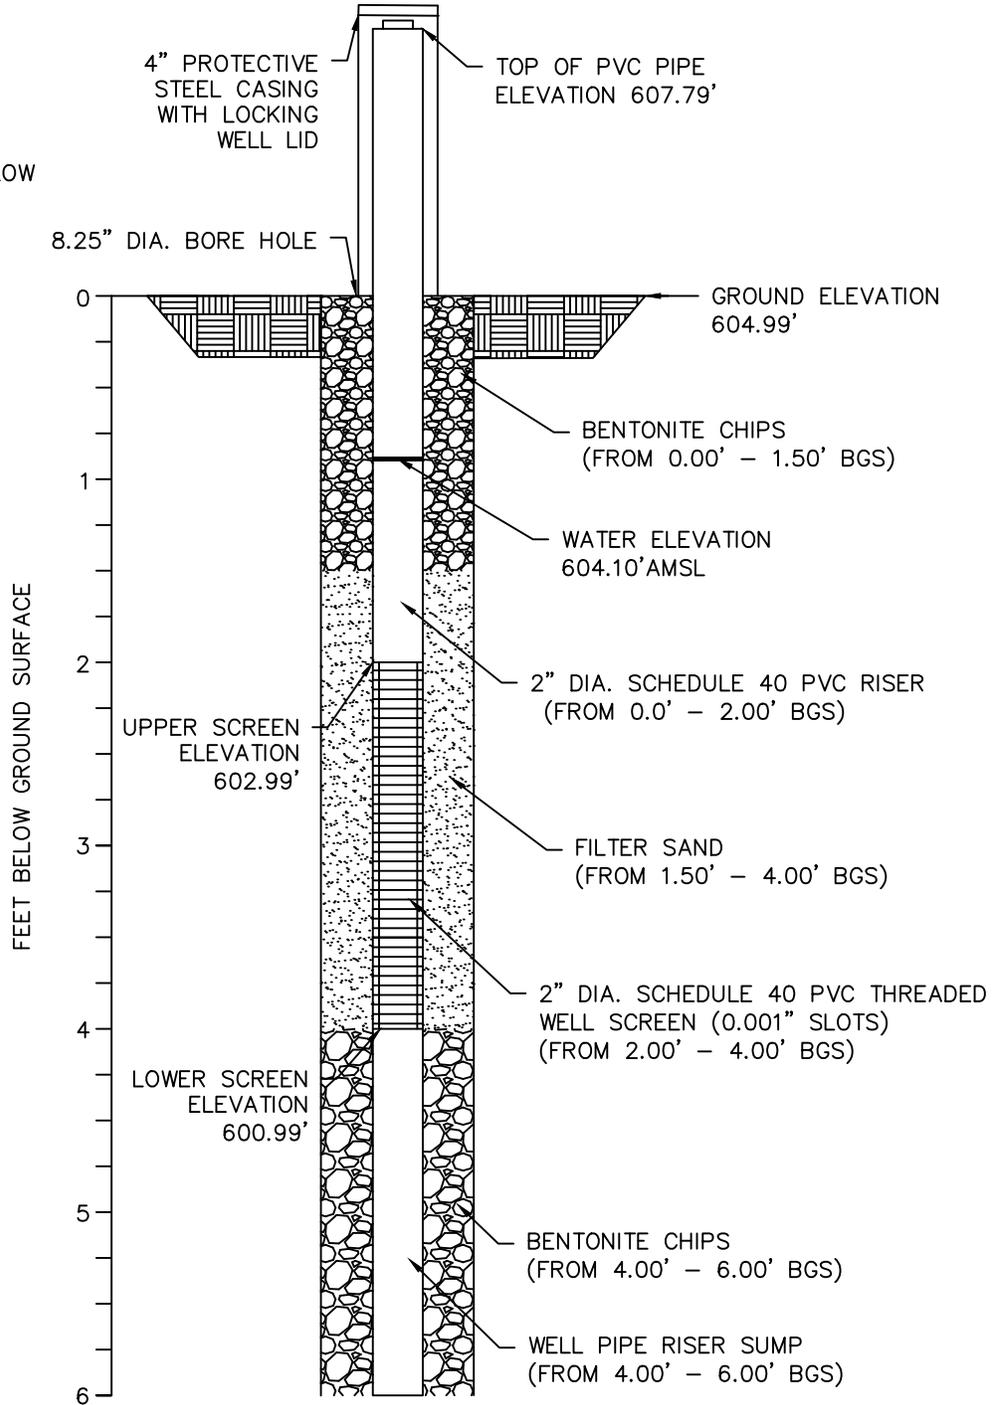
WELL ID: MW-BCP-06A  
 DRAWING NUMBER  
 D-113

DRILLER: EARTH DIMENSIONS  
 DRILLING METHOD: 4.25" HOLLOW  
 STEM AUGER

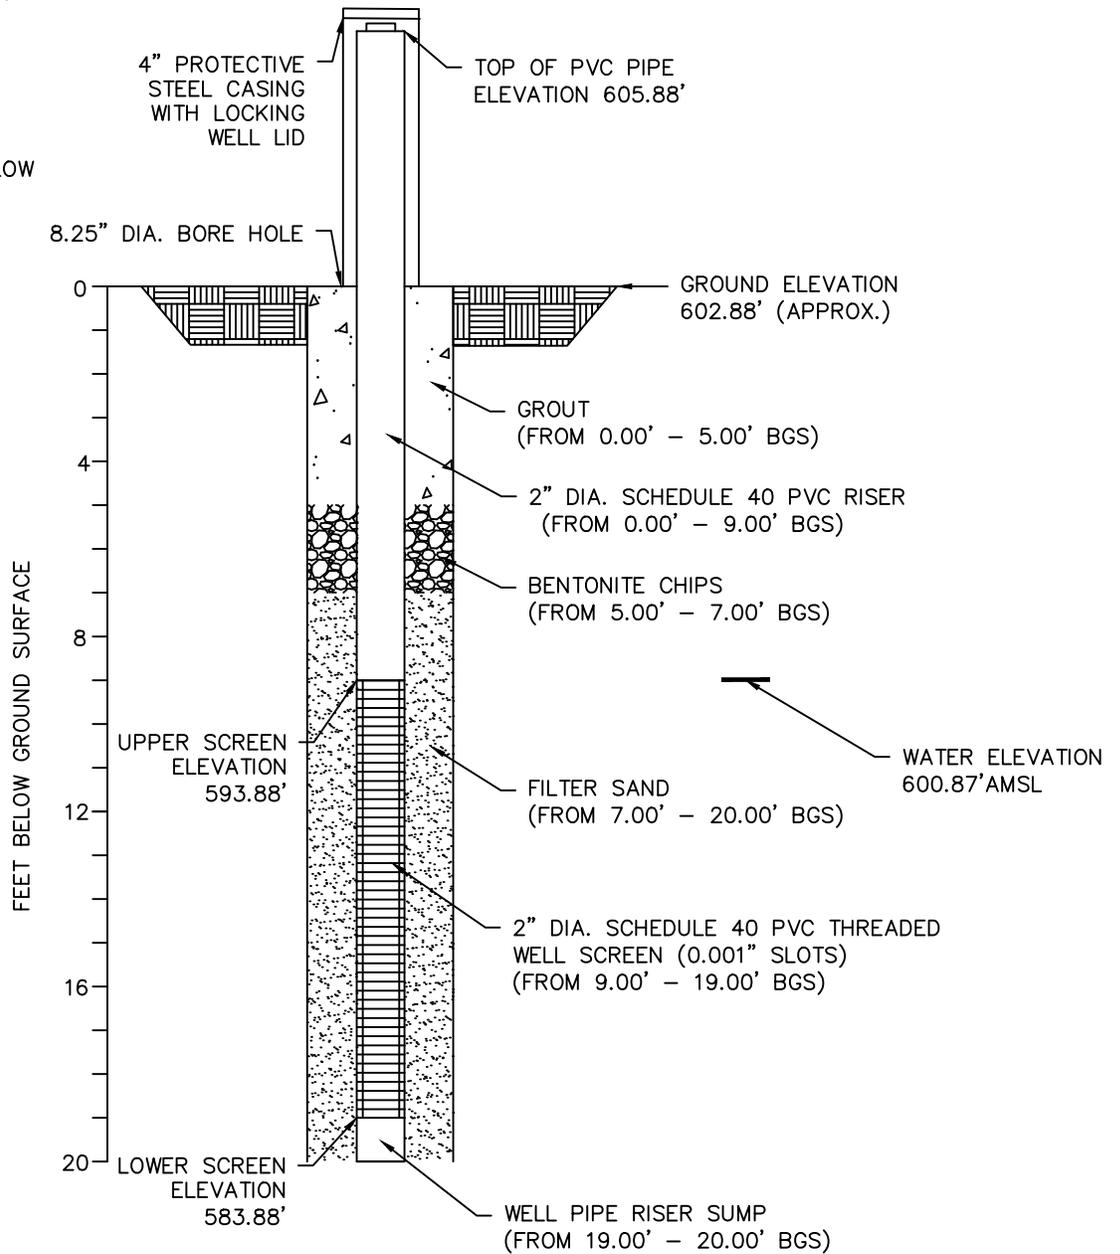
# MONITORING WELL MW-BCP-26B (N.T.S)

NOTE: GROUND ELEVATION IS ESTIMATED. UPPER AND LOWER SCREEN ELEVATIONS ARE THEREFORE ALSO ESTIMATED.
