RE: Abandoned Pipeline IRM Work Plan  
Riverview Innovation & Technology Campus, Inc.  
Brownfield Cleanup Program Site No. C915353  
Town of Tonawanda, New York

Inventum Engineering, P.C. (Engineering), on behalf of Riverview Innovation & Technology Campus, Inc. (Riverview), is submitting this Abandoned Pipeline Interim Remedial Measure (IRM) Work Plan (work plan) to the New York State Department of Environmental Conservation (NYSDEC) for the Riverview Brownfield Cleanup Program (BCP) Site (#C915353) located at 3875 River Road, Tonawanda, New York.

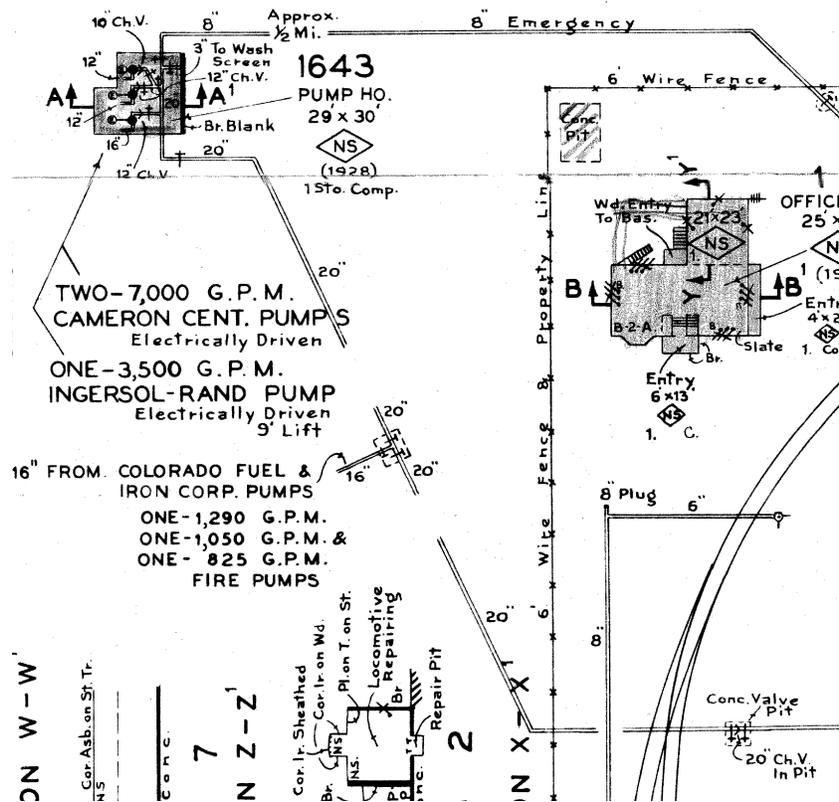
**Excerpt from T-M-57A-F**  
(Not to Scale)

1. Break Lines, indicating the sections of pipe on former Wickwire Spencer property.
2. The property line shown on this excerpt was before the parking lot that was purchased from Wickwire Spencer.

The water pipe route was from a pump house located on the Niagara River (4008 River Road) to a valve pit on the BCP Site. The water pipe is listed as a 20-inch diameter pipe on Drawing T-M-57A-F (n.d.) and according to the figure was supplemented with an emergency 8-inch diameter pipe along the railroad tracks north of the site that entered the property northeast of the Mansion and, an emergency 16-inch diameter supply pipe from Colorado Fuel & Iron (a/k/a CF&I) that joined at some point west of River Road. It is likely that the CF&I emergency pipe joined the 20-inch diameter pipe west of the Erie Canal on what would have been the steel mill property.

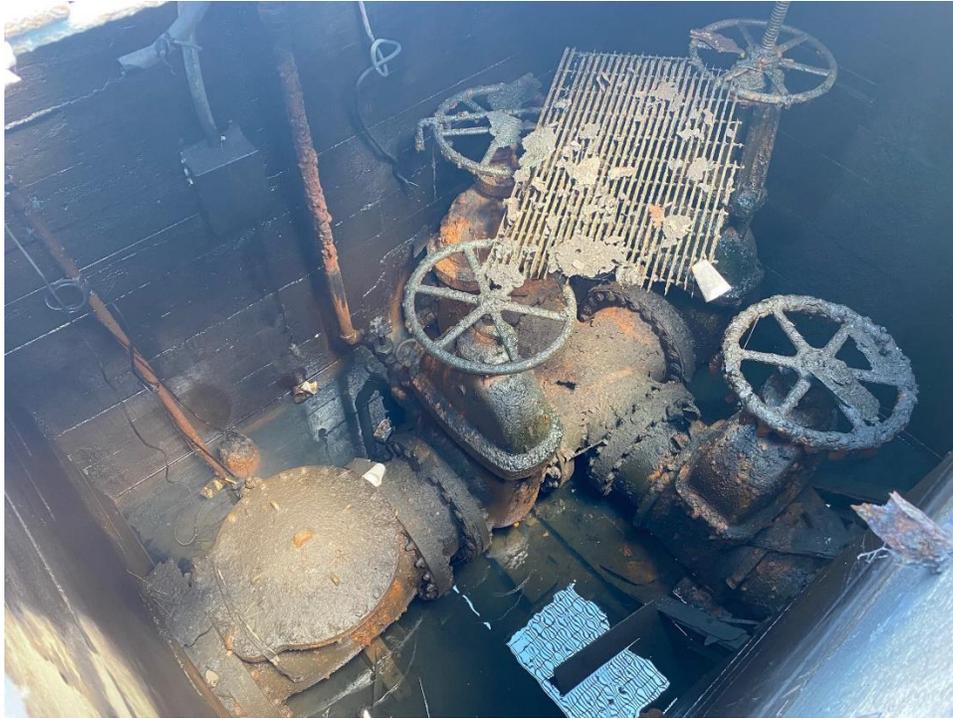
**Photograph No. 1**

Valve Pit – Former Water Supply Junction

(Note: three valves closed and Backflow Preventor)

The valve pit for the water pipe contains four valves (three are closed) and a backflow preventor (Photograph No. 1). This combination of closed valves eliminates any risk of flow through the water supply line toward River Road. The water pipe is carried over a pipe bridge above River Road which shows there is no possibility of flow along the pipe reaching the former Erie Canal or the Niagara River.

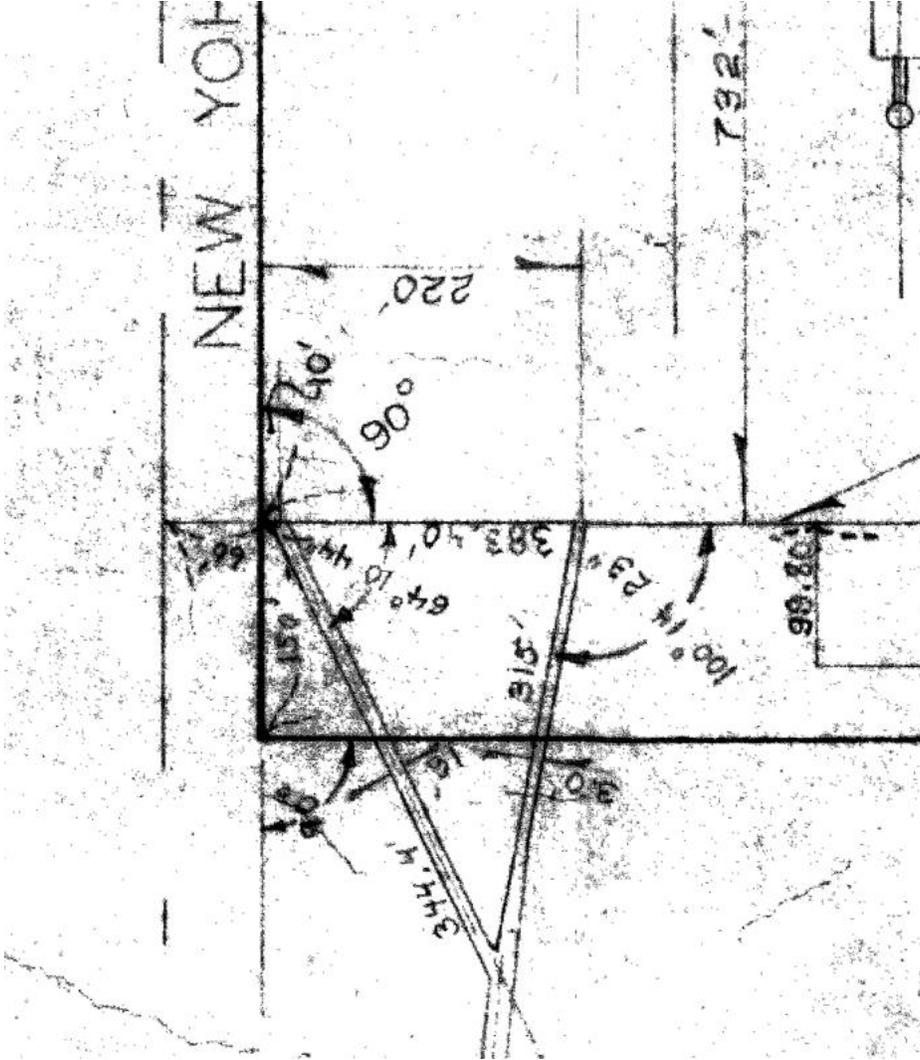
Excerpt from T-R-25

- 1. North is to the left.
- 2. The rights of way are shown from the Wickwire Property west.

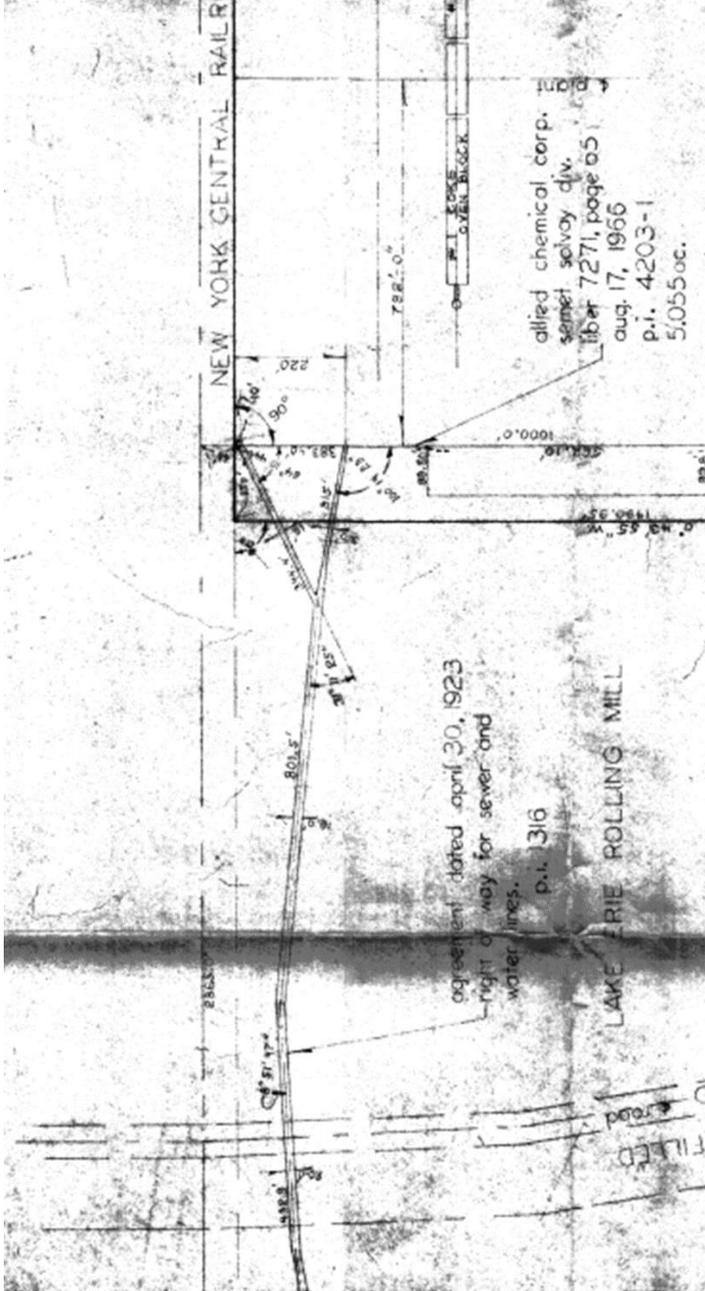
**Excerpt from T-R-25**

- 1. North is to the left.
- 2. The rights of way are shown from the Wickwire Property west to River Road.
- 3. The pipe is above ground across River Road, therefore no possible transport.

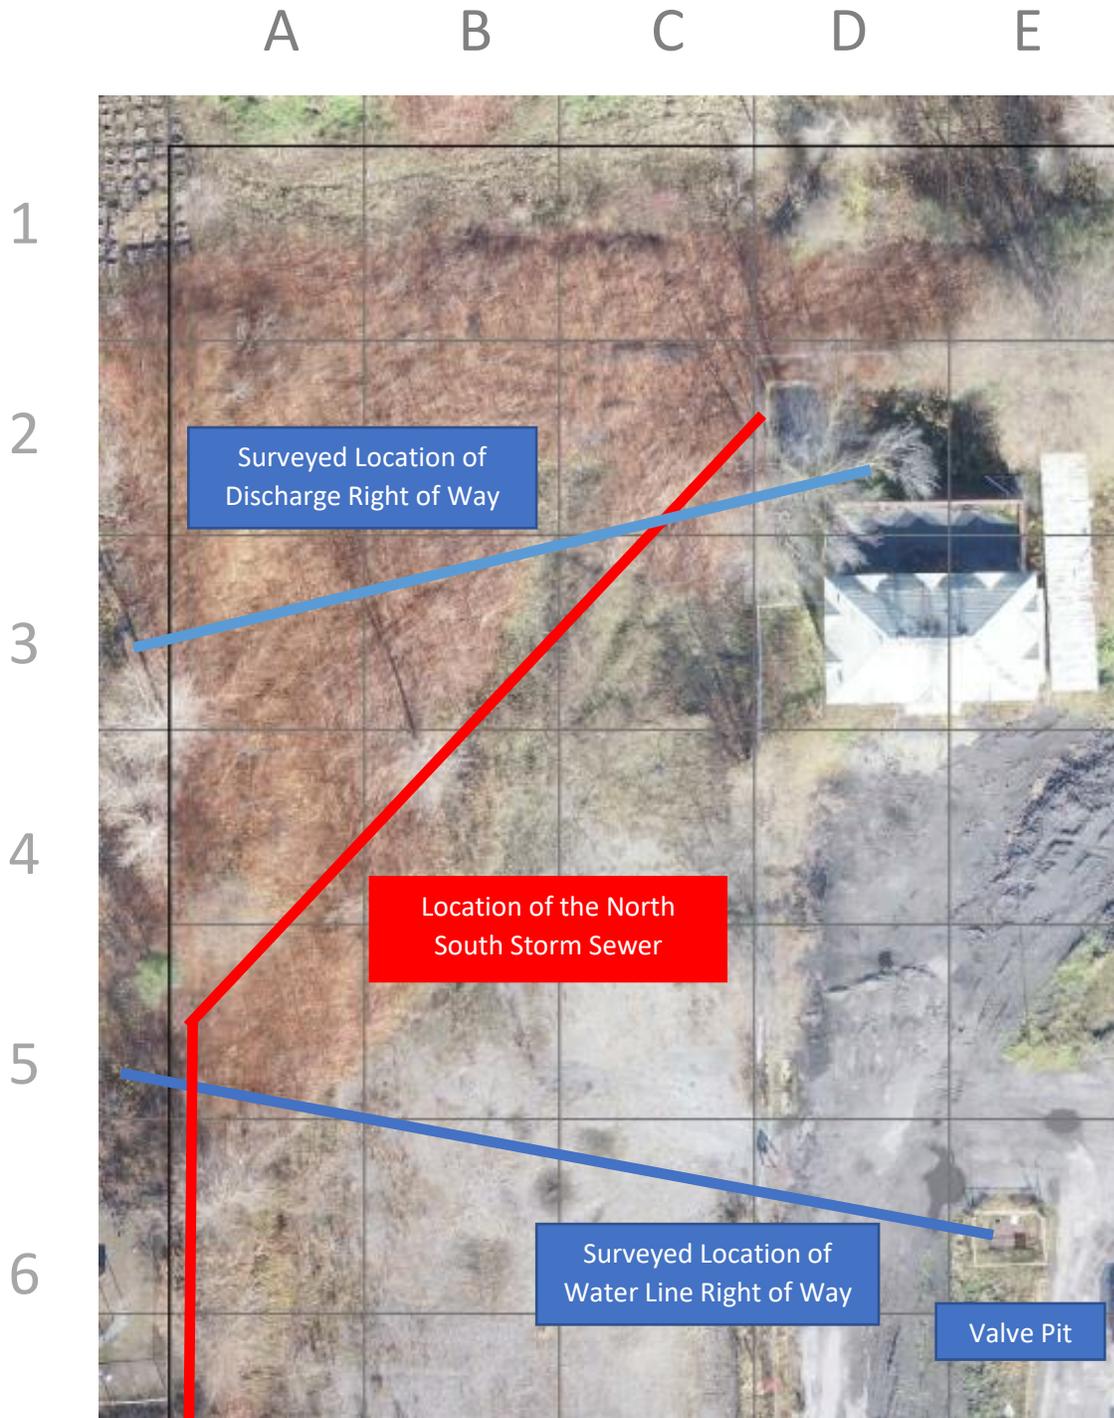
**Location of Water and Discharge Rights-of- Way**

1. The surveyed rights-of- way do not exactly coincide with the Drawings available from the plant.
2. The location of the junction of the pipe from CF&I is unknown but is most likely on the Niagara River World property.

The scope of work will provide the opportunity for definitive observations at the locations cross the western property line shared with Swift River Associates Inc. (Swift River) and the north boundary with the railroad right of way. The three locations that pipes may cross the property line are shown on the partial aerial photographs (Niagara Boundary, 2019) below.

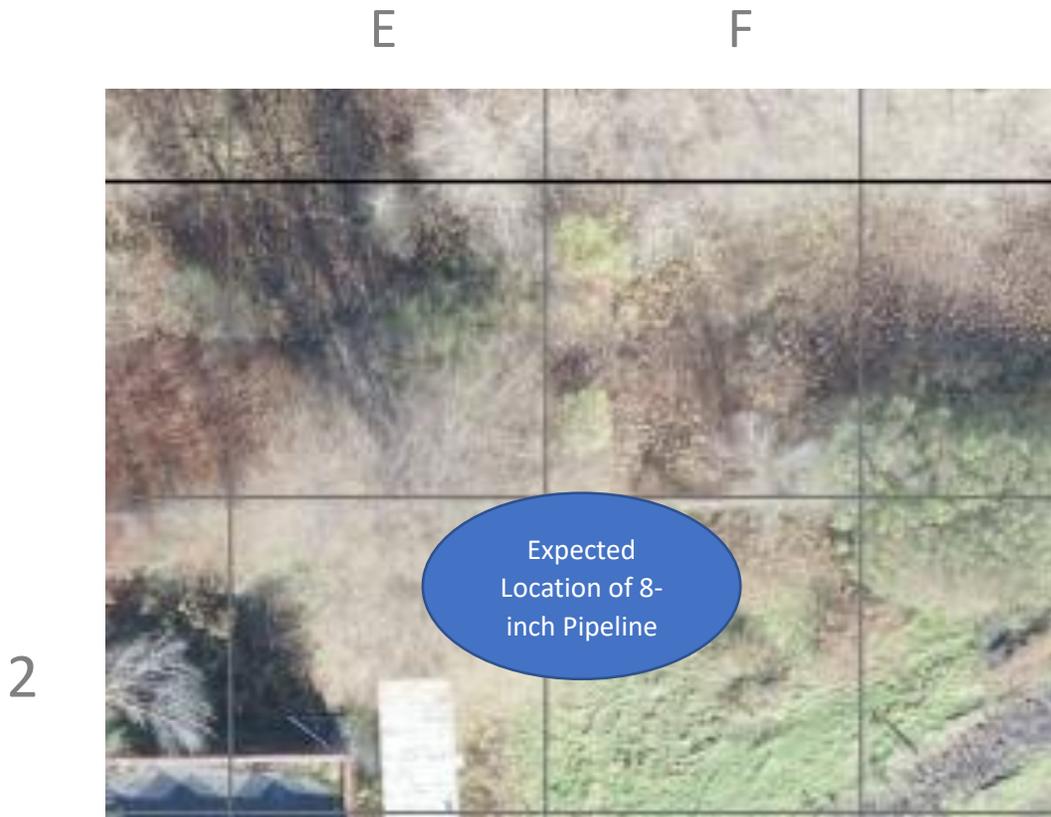
**Location of Potential 8-inch Diameter Emergency Water Pipe**

1. The Mansion is in the lower right corner.
2. The office trailer next to the Mansion is the white rectangle.

The test pit for the 8-inch diameter emergency water pipe may require more investigation as there is no known exposed pipe. The excavation should start between the office trailer next to the Mansion and proceed east across Grid E-2.

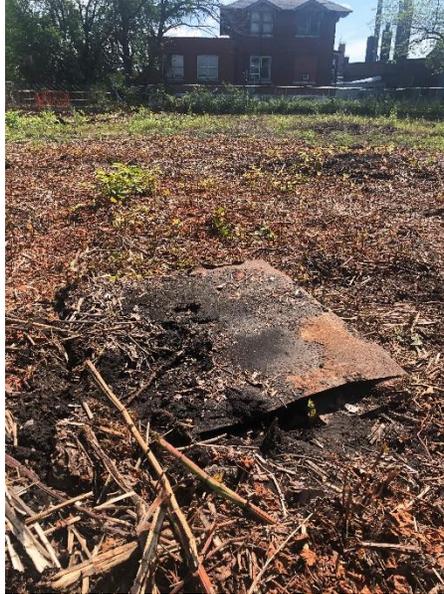
**Brick Structure**

1. The brick structure is approximately 4 feet square.
2. The Mansion and Mansion Sump are directly east (photograph facing east).

The test pit across the discharge line will likely be in Grid A-3 or A-4. This location should be north of the North South Storm Sewer, but caution will be exercised while excavating. There is also a brick structure in Grid B-2 that may be part of the abandoned discharge line or that may have other buried utilities. The area between the brick structure (under the metal plate in the next picture) and the property line will be investigated and cleared by the proposed test pit across the discharge pipeline.
